Document:	R.B20447.003.05.Final.doc
BMT WBM Pty Ltd Level 8, 200 Creek Street	Title:	Norfolk Beach SES
Brisbane 4000 Queensland Australia	Project Manager:	Malcolm Andrews
PO Box 203 Spring Hill 4004	Author:	Malcolm Andrews
Tel: +61 7 3831 6744 Fax: + 61 7 3832 3627	Client:	Redland City Council
ABN 54 010 830 421	Client Contact:	Toby Ehrsam
www.bmtwbm.com.au	Client Reference:	30493

Synopsis: This draft document is a Shoreline Erosion Study for Coochiemudlo Island. The

report outlines the legislative framework, coastal processes and recommended

erosion management strategies.

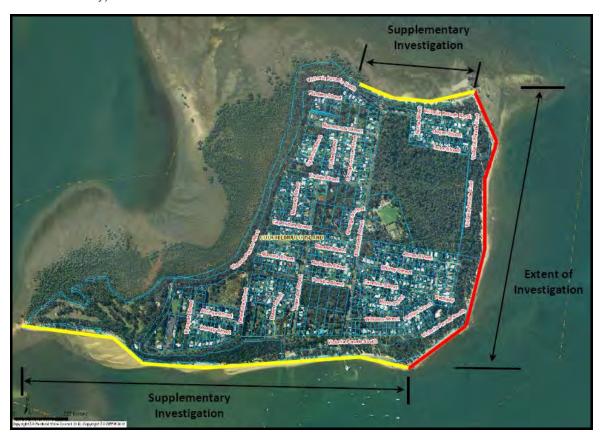
Figure 1-1 Study area

The study area includes primarily the eastern beaches of Coochiemudlo Island as shown in red in Figure 1-1 below (from RCC brief). However, Council has also chosen to accept the supplementary extension to the study area which includes the beaches to the south and north of the island (yellow areas).

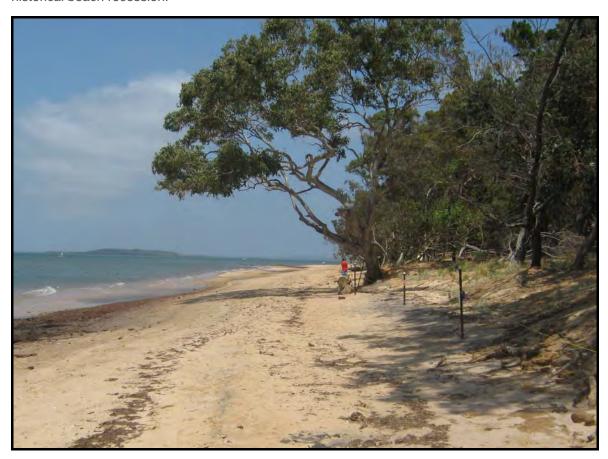
Figure 4-1 Gum Tree on Norfolk Beach

Preliminary evidence from investigating historical aerial photos dating back to 1955 suggests that there have been significant changes particularly along the north eastern beaches and to a lesser extent the southern corner. It is also noted that the existence of Eucalyptus trees at the current beach line (refer Figure 4-1) suggests long term shoreline recession. Ecologists suggest that these are at least 60 years old and would not have grown adjacent to the beach suggesting significant historical beach recession.

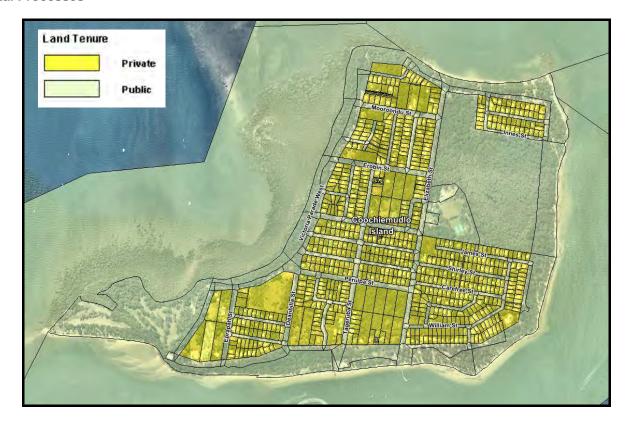
Figure 4-2 Coochiemudlo Island Cadastre

Similarly there is some indication from cadastral boundaries that the current shoreline is westward of the original cadastre. However, it should be noted that early cadastre in Australia used several indicators of the coastline. These included some loose terms such as high tide mark, low tide mark and sometimes a more accurate survey of "meets and bounds" where the surveyor defined the land/sea boundary. It would appear that the coastal cadastre of Coochiemudlo Island is based on one of the looser tidal boundaries because of its irregular shape (refer Figure 4-2).

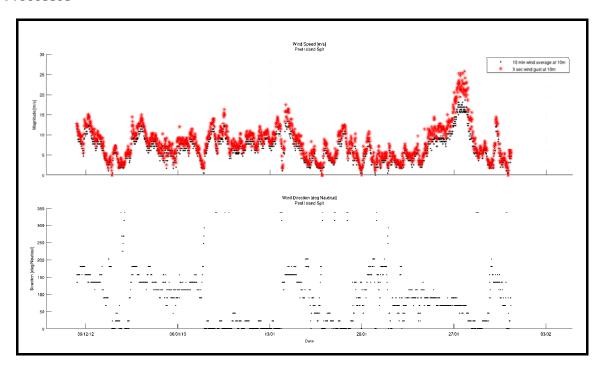
Figure 4-3 Wind speed at Peel Island January 2013

The wind plot for Peel Island for January 2013 (refer Figure 4-3) indicates winds of 10m/s (approx. 20 knots) for most of the month with a peak on 26th January in excess of 25m/s (approx. 50 knots).

Extreme events such as these can drive coastal processes at a rate that is equivalent to many years of ambient weather particularly when combined with high tide levels as was the case during ex TC Oswald.

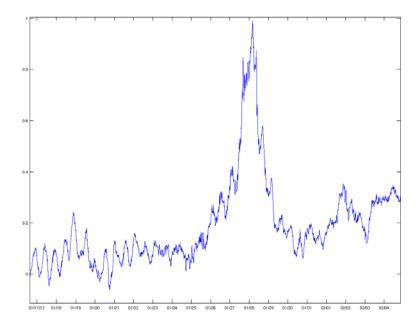
Figure 4-4 Surge at Brisbane Bar during ex TC Oswald

The tidal records (predicted and recorded) for Brisbane Bar have been received from Maritime Safety Queensland and the residual (i.e. storm surge) measured at that location was ~1m as shown in Figure 4-4. On closer inspection (refer Figure 4-5) the maximum surge occurred on the lower tide during the early morning of the 28th however the high tide levels were elevated from the morning of the 27th to the morning of the 28th (3 high tides). It is unlikely that the same surge was felt at Coochiemudlo Island due to the significantly reduced fetch across the Bay. However, the spring high tides at the time would have been enhanced by a significant fraction of the Brisbane Bar surge. An indication of the tide height and wave conditions is shown in Figure 4-6 (courtesy Coochiemudlo Island Coastcare).

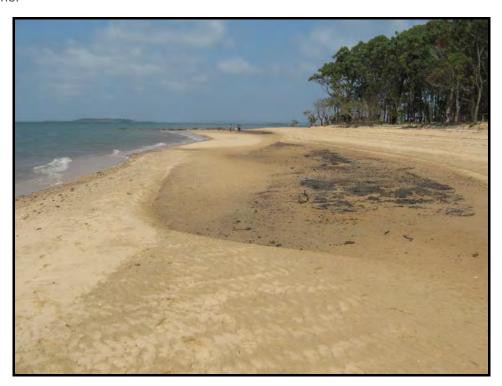
Figure 4-7 Sand returning to shore by cross-shore processes

Figure 4-7 below shows sand slowly returning to the beach in the form of low shoals near the water line.

On dynamically stable beaches, there is balance in the amount of sand that is taken offshore and is subsequently returned to the beach and dune. On beaches were the nearshore consists of significantly finer, cohesive material (i.e. mud), such as those within the study area, the transport back to the beach may be complicated and some beach material may be permanently lost offshore.

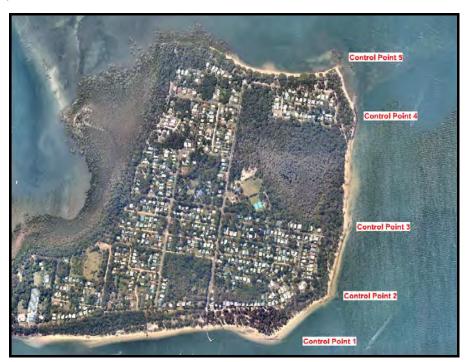
Figure 4-8 Eastern beaches alignment control points

- Sand, which is transported around the south eastern corner of the island during north easterly waves, moves westward along the South East Beach under the influence of subsequent south easterly waves until it reaches the western end of that beach. Under normal tide conditions there is no sand transport onto the eastern end of Main Beach at high tide, since the rocks there are sufficiently high and aligned favourably for the formation of a tombolo between them and the high water line on the shore behind them. However, at low tide south easterly waves transport sand westward around the seaward side of this "offshore rocky breakwater", forming a sand spit extending westward offshore of the eastern end of Main Beach. Eventually the western end of this spit joins the face of the beach somewhere east of the jetty and sand moving along it continues its westward journey along Main Beach whenever south easterly waves occur.

• The westward moving sand has been bypassing the Curlew Creek mouth for as long as observations/photos have been made and this sand has formed large sand shoals on the intertidal flat westward of the red cliff on which the community hall is located. Sand from these shoals subsequently is moved by waves onto the South West (Golf Links) Beach, where it continues its westward journey to the south western corner of the island and thence across the intertidal flat and off the island into the channel between the island and the mainland. This westerly sand transport is clearly indicated by the shape of the sand shoals and spits on aerial photos and results in an ongoing (although apparently low) loss of sand from the Coochiemudlo Island system.

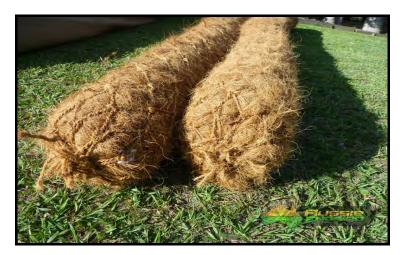
Figure 6-1 Coir Logs and Sand Filled Geofabric Bags

Coastal protection structures are typically of a sand filled geofabric container or flexible mound rock construction type. However, in a low energy environment such as Coochiemudlo Island sand filled geofabric containers and coir logs (refer Figure 6-1) may be beneficial.

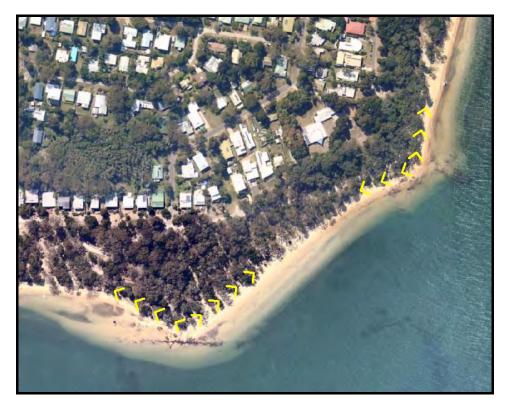
Figure 6-2 Locations for dune enhancement

The dune enhancement is aimed at stabilising the beach alignment. However, the current beach alignment is already resulting in some threats including erosion of the Norfolk Beach Track, disturbance of beach access and exposure of trees roots. Each of these is considered below.

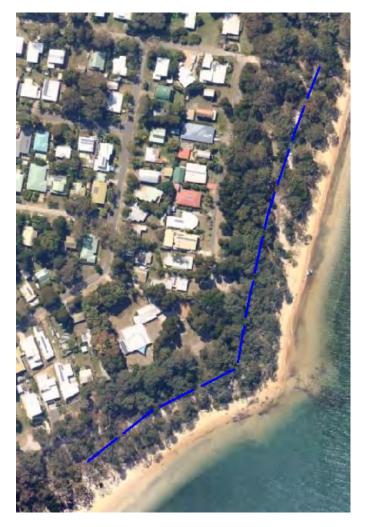
Figure 6-3 Setback for Norfolk Beach Track

The erosion prone area calculations in Chapter 5 indicate that over a planning period of 50 years it is possible that up to 22m or erosion could occur from extreme events (excluding sea level rise). Therefore, it is recommended that the track should be located about 22m from the shoreline to be free of extreme cyclonic wave runup and inundation threats (excluding future climate change induced sea level rise). Over time if sea levels rise then this distance may need to be increased. This means that in some places the track will need to be relocated landwards with low disturbance beach access routes to the shore (e.g. plastic planking). An approximate setback line is shown in Figure 6-3 but will need local knowledge of trees and an assessment of natural surface elevations for final arrangement. It is also recommended that where possible stormwater and road drainage be directed away from the beach or controlled in sheet flows such that it does not become concentrated and cause scouring.

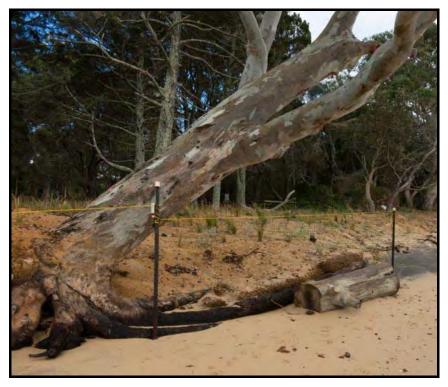
Figure 6-4 Tree needing protection (courtesy Coastcare)

For protection of the gums on Norfolk Beach it will be necessary to gain advice and the extent of protection required (e.g. radius from tree) and any particular fill requirements (e.g. depth of sand / topsoil). Also, it should be noted that if long term recession is still occurring then the trees will eventually be outflanked and protection measures will no longer be effective.

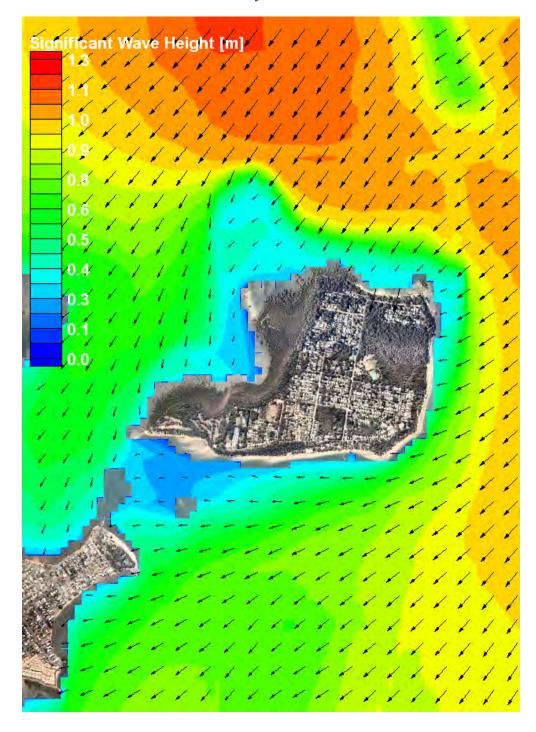
South Easterly wave Conditions

Predicted high tide peak wave conditions from the southeast and northeast are shown as contour with vector plots in Appendix F. The modelling indicates storm wave conditions of around 0.8m (Hs) with a period of about 4s (Tp) for these scenarios with longshore transport potential on the eastern beaches to the north during south easterly conditions and conversely to the south in north easterly conditions.

Beach	NE Wind Field		SE Wind Field			E Wind Field			
	Hsig	Тр	Dir	Hsig	Тр	Dir	Hsig	Тр	Dir
Morwong Beach	0.8	3.8	27	0.6	3.5	90	0.7	3.5	61
Melaleuca Beach	0.8	3.8	61	0.8	3.3	121	0.8	3.4	88
Norfolk Beach	0.8	3.7	70	0.8	2.9	125	0.8	3.5	90
Southeast Beach	0.7	3.5	86	0.7	2.9	131	0.7	3.6	102
Main Beach Central	0.5	3.7	95	0.7	2.9	138	0.6	3.6	114
