Coochiemudlo Island Shoreline Erosion Management Plan and Operational Plan

Reference: R.B23255.002.04.CMI_SEMP.docx
Date: November 2020
Confidential

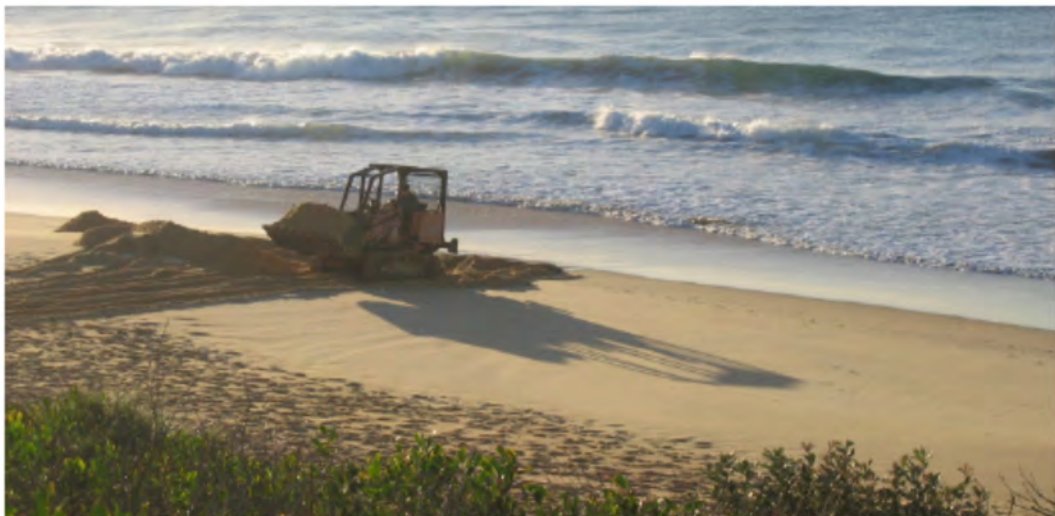
Figure 3-1 Beach Re-profiling using Mechanical Equipment (Carley et al., 2010)

Beach reprofiling, or “beach scraping”, generally involves relocating sand from the lower part of the beach to the upper beach and dune system using mechanical equipment (refer Figure 3-1 and Appendix C). The action is assumed to mimic natural beach recovery processes, albeit at an increased rate.

Beach reprofiling can be successfully used to restore beach amenity, widen the upper beach and rebuild dunes. These actions will temporarily improve the protection of adjacent assets by increasing the beach width. Such works are relatively inexpensive, can be implemented quickly and are often undertaken in response to a significant beach erosion event. The main shortcoming of beach reprofiling as an erosion control measure is it needs to be repeated frequently and may only offer limited shoreline protection.

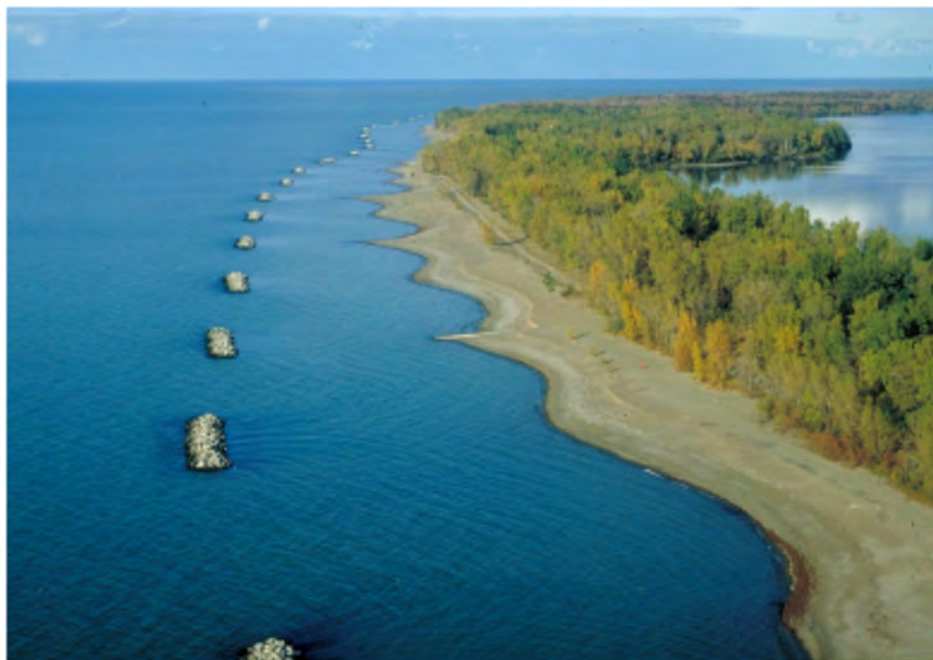
Figure 3-3 Offshore Breakwater Series and Salient Formation (U.S. Army Corps of Engineers, 2002)

Emergent offshore breakwaters (with crest level above the water surface at some or all stages of the tide) are commonly used to reduce wave induced beach erosion in the United States, Europe and Japan. Offshore breakwaters are typically constructed parallel to the shoreline and slightly seaward of the surf zone. The structure is intended to dissipate part of the incident wave energy and reduce the direct impact of storm waves. Under prevailing conditions, the presence of a breakwater will modify wave, flow and sediment transport patterns in the lee of the structure may promote the growth of a shoreline salient or tombolo. This effectively widens the target area of the beach and provides an additional erosion buffer. Offshore breakwaters are often constructed in a series to protect long sections of coastline, similar to a groyne field however with the advantage of not completing blocking longshore sediment transport (unless tombolos form).

A major problem associated with the construction and maintenance of offshore breakwaters is their significant design requirements and large cost. By design, offshore breakwaters must be placed in the most energetic part of the nearshore zone which leads to operational difficulties during construction and renders them prone to damage during severe wave conditions.

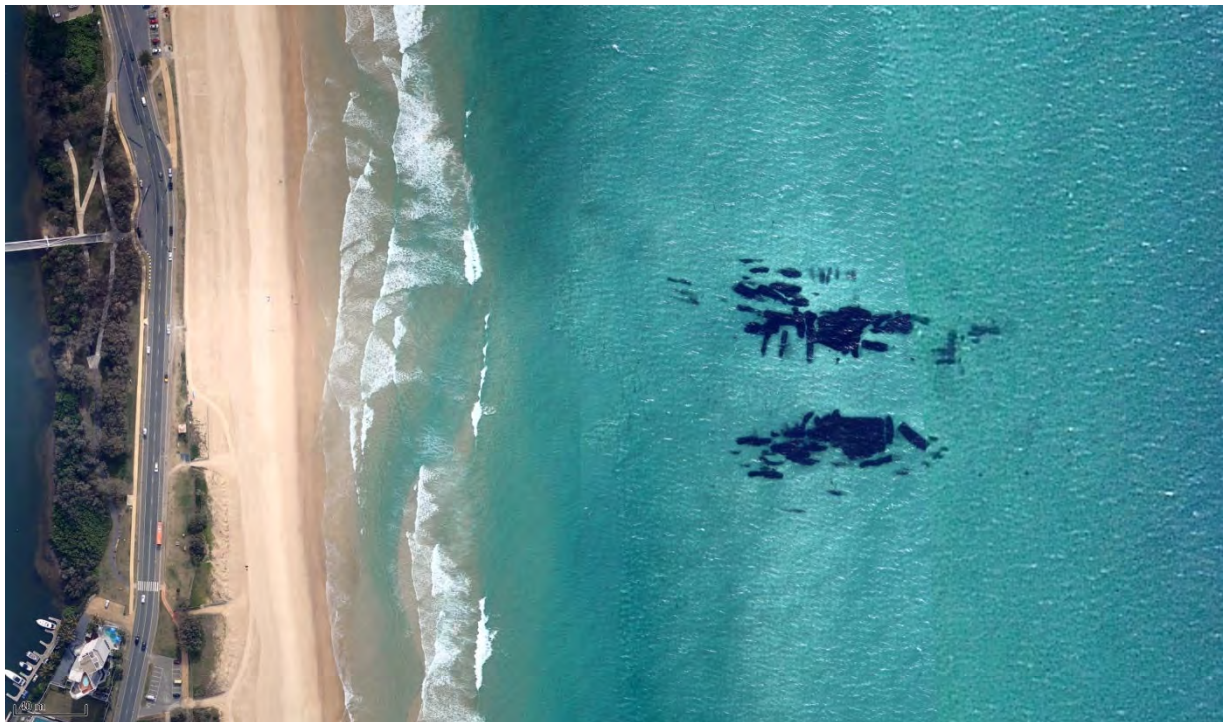
Figure 3-4 Geotextile Sand Container Artificial Reef at Narrowneck, Gold Coast (Source: NearMap, 2011)

sediment transport patterns and can lead to the formation of a salient in the lee of the reef and therefore widens the beach. In this regard, a submerged artificial reef is intended to function in a similar way to an offshore breakwater (noting that the crest of a traditional breakwater is above the water surface). Some submerged reefs, such as 'The Twins' at Narrowneck on the Gold Coast (see Figure 3-4), attempt to combine shoreline protection with recreational surfing and/or snorkelling/SCUBA diving benefits and are referred to as 'multi-purpose submerged reefs'. Submerged reefs don't intrude on the beach and have the advantage of low visual impact. Consequently, the scenic amenity of an area is not altered.

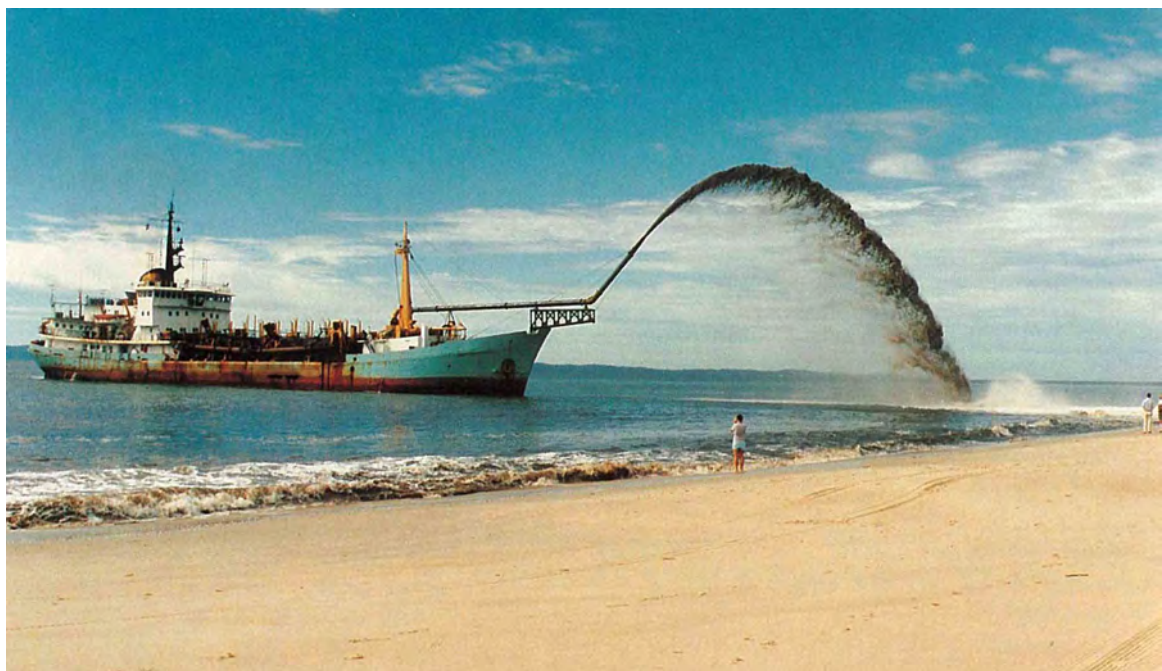
Figure 3-5 Nourishment Sand being Delivered ‘over-the-bow’ to Woorim Beach

Port of Brisbane Pty Ltd maintenance dredge material is currently used by Council to nourish the beach at Woorim (refer Figure 3-5).

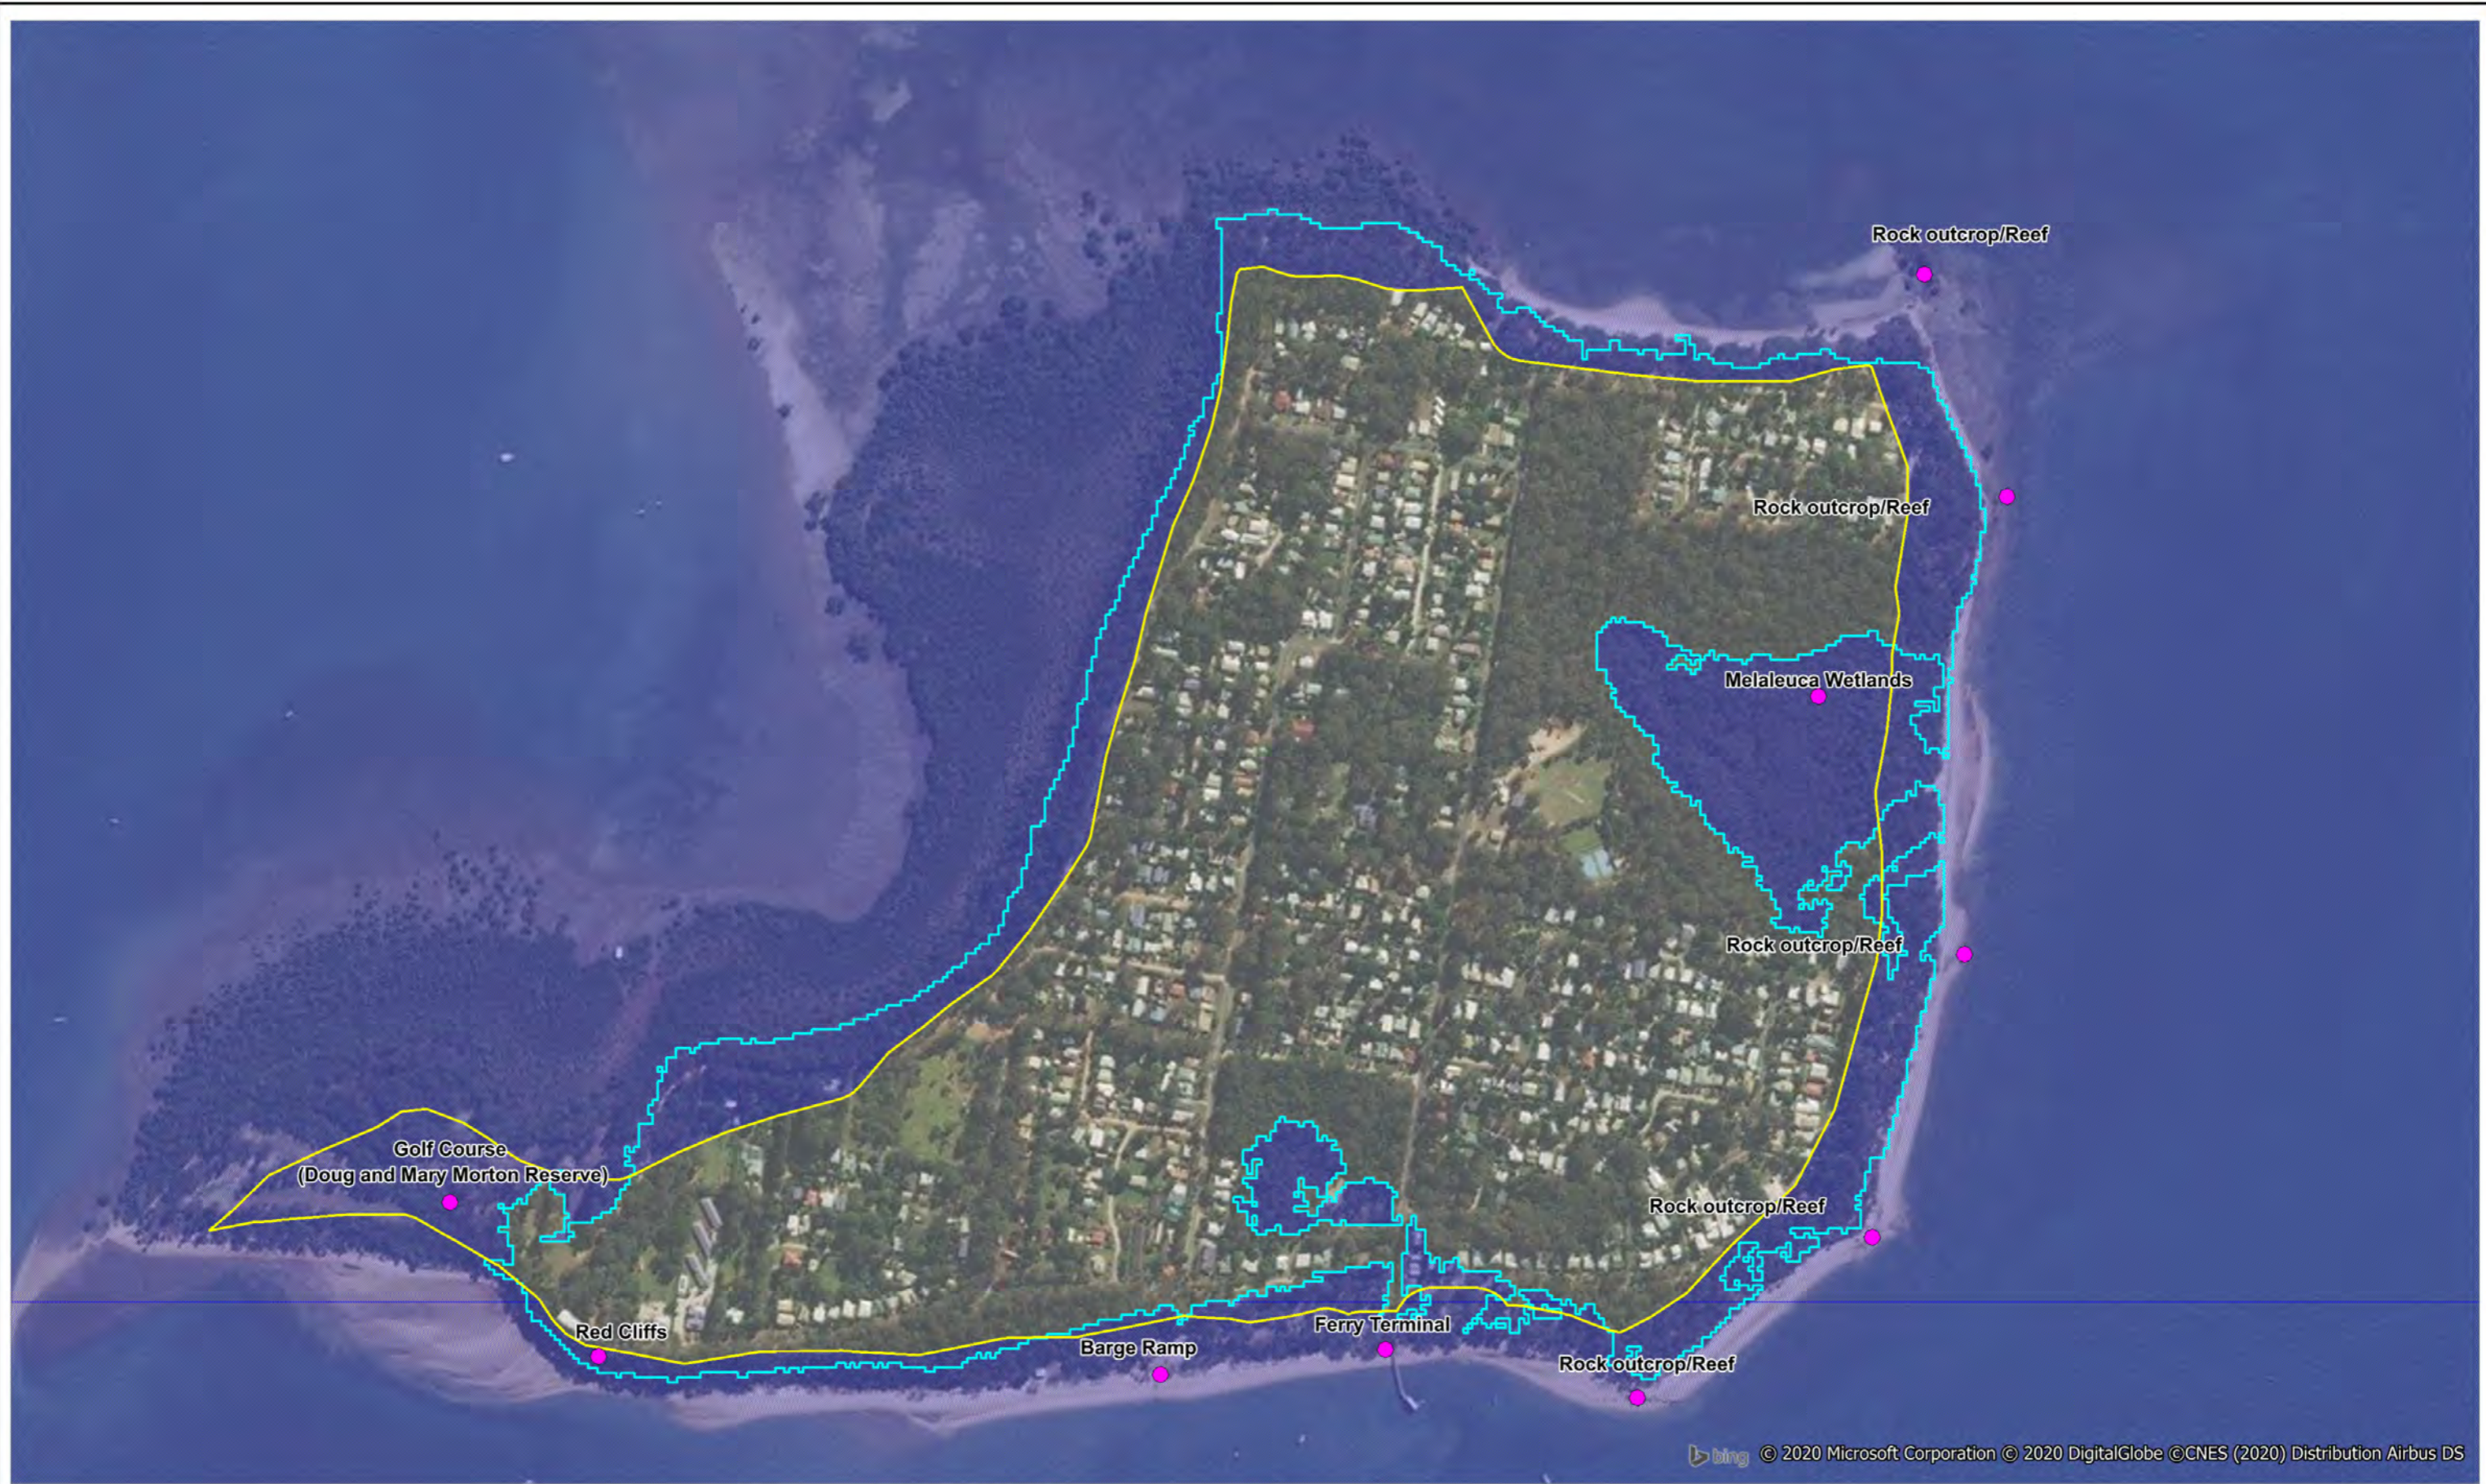
- LEGEND:**
- Topographical feature
 - Erosion Prone Area (All Components)
 - 40m Buffer on HAT
 - HAT+0.8m Sea Level Rise

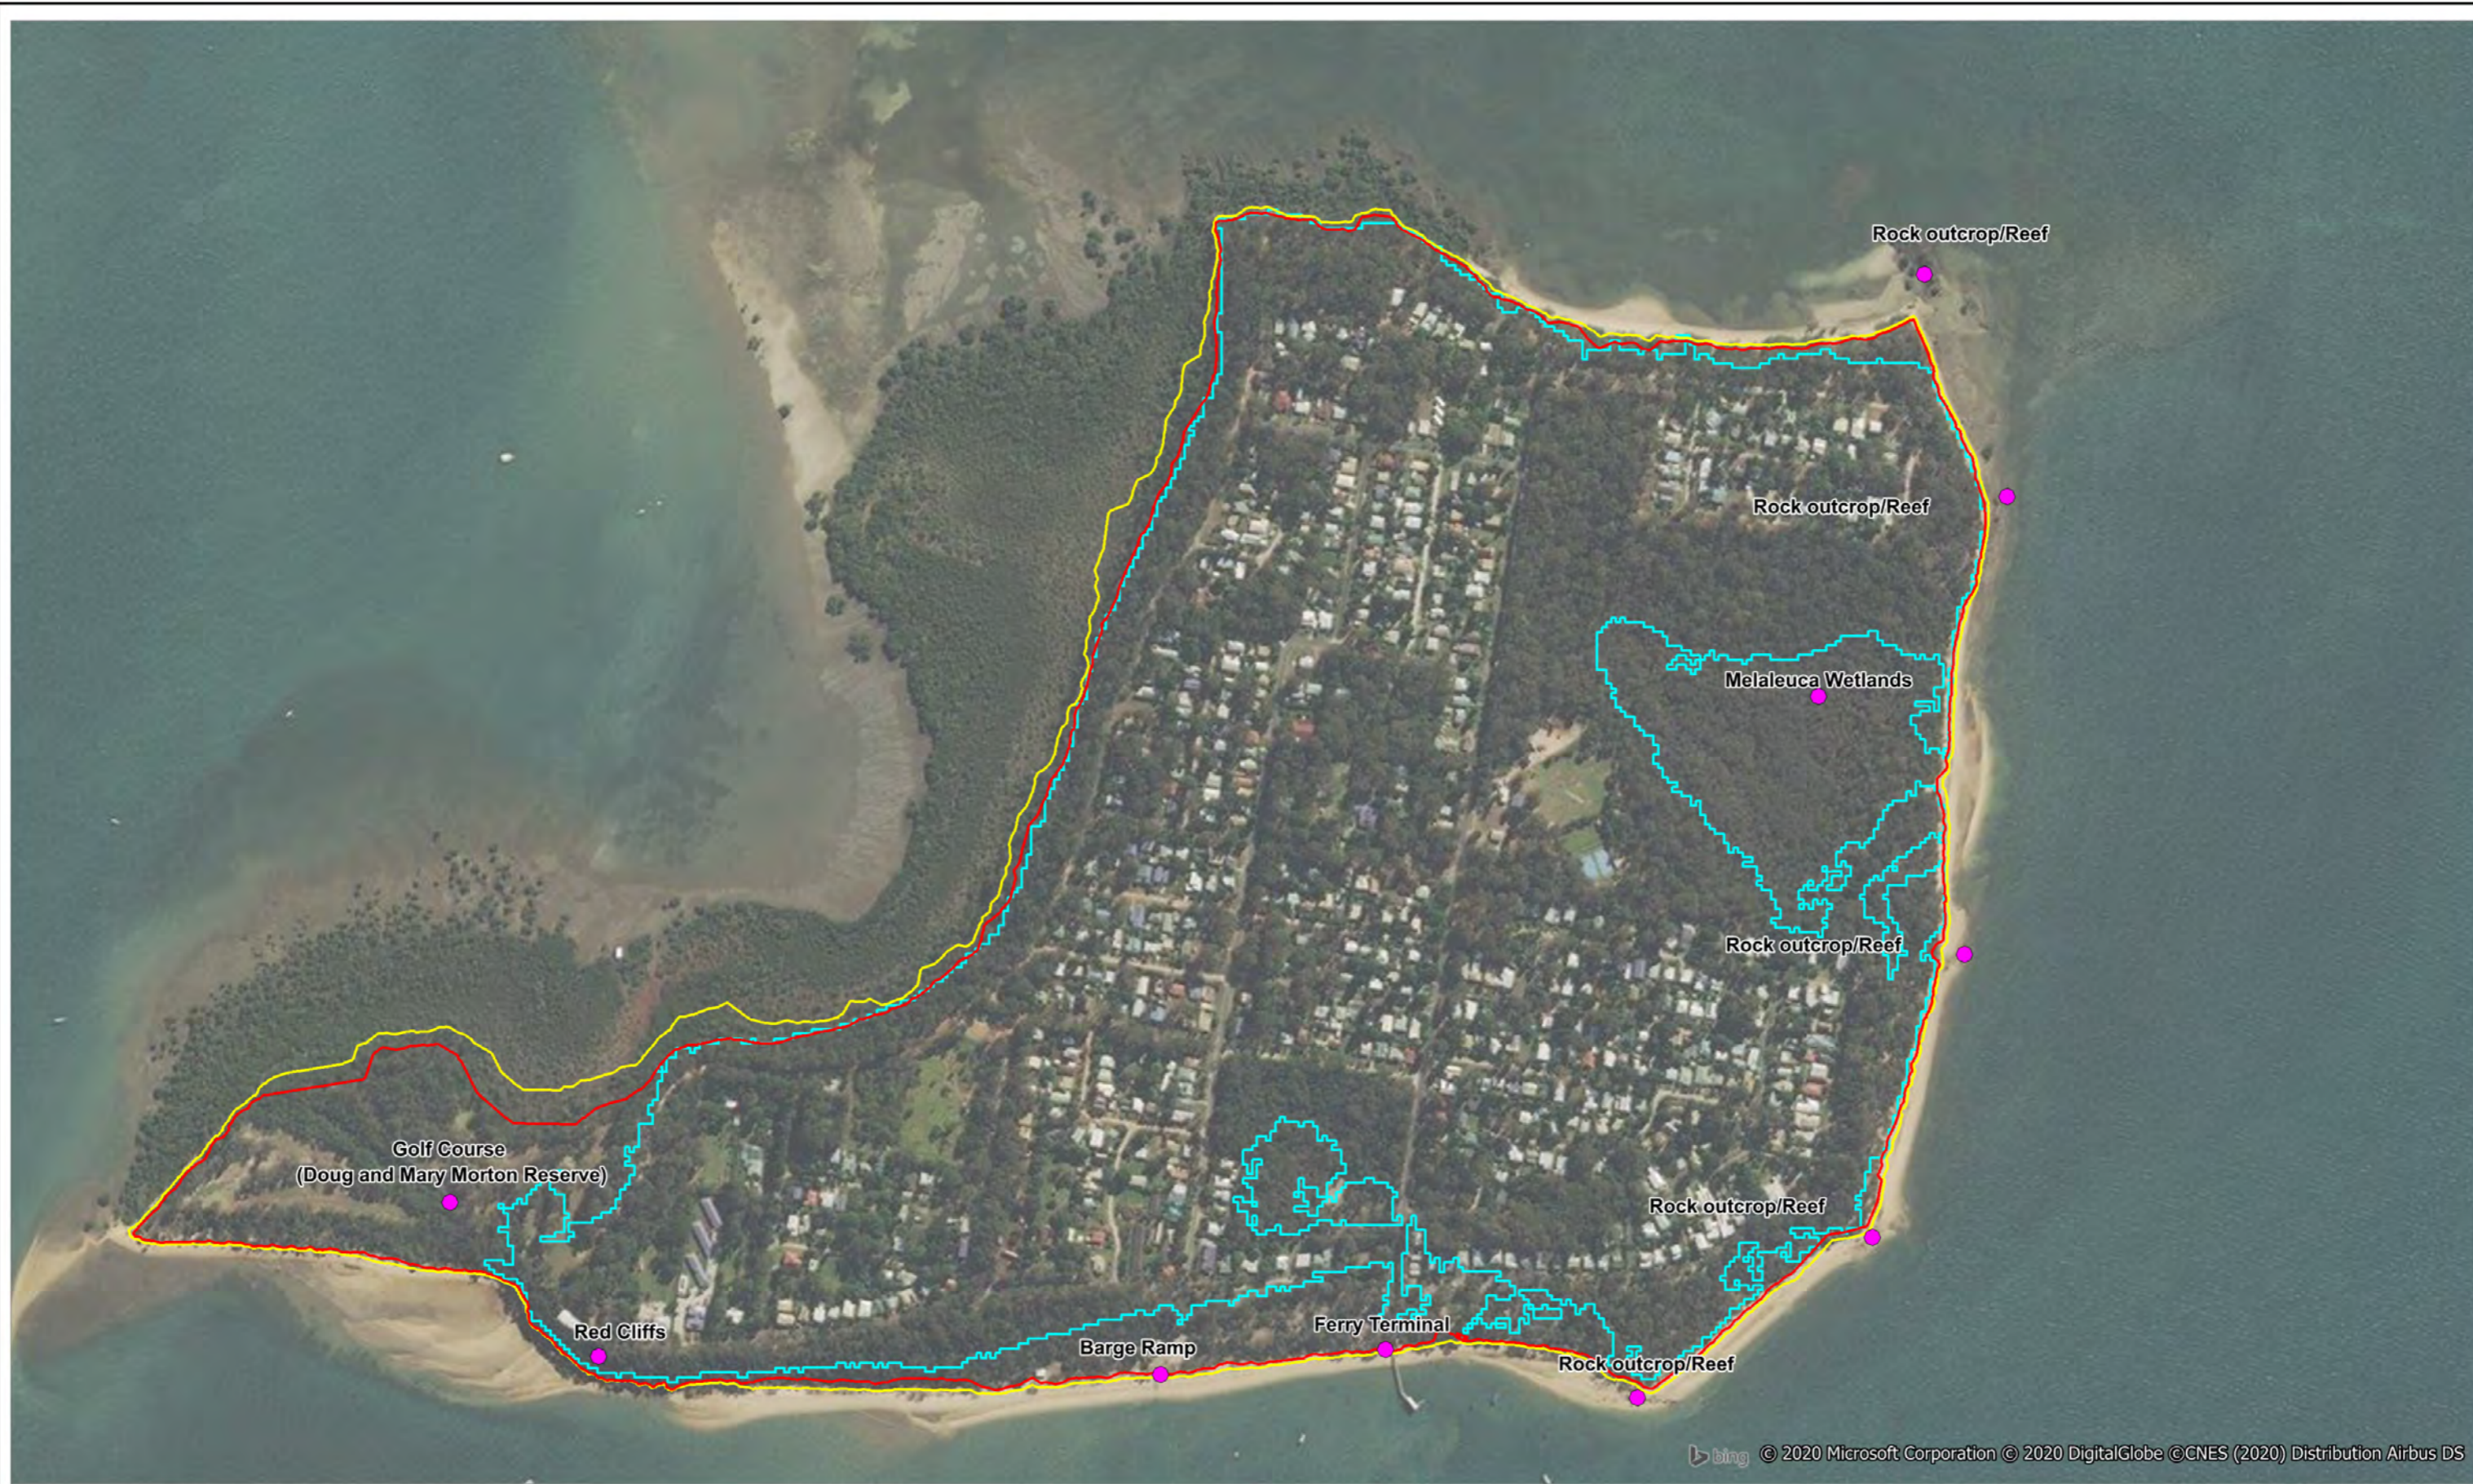
- Legend**
- Topographical Features
 - HAT
 - HAT + 0.4m Sea Level Rise
 - HAT + 0.8m Sea Level Rise

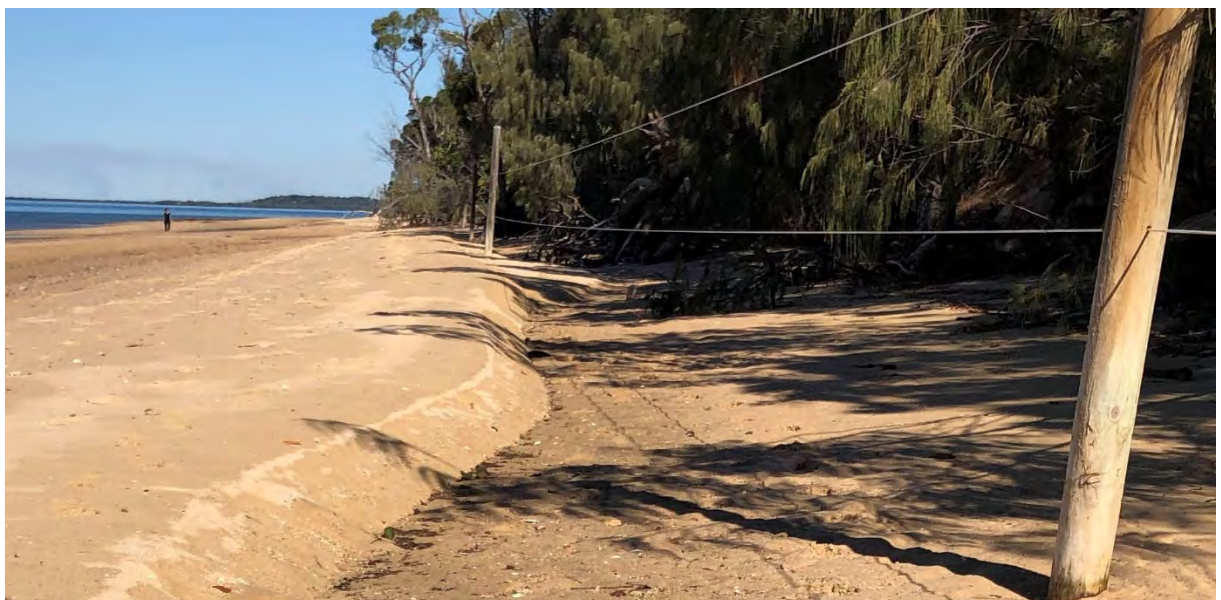
Figure 4-1 Active beach recovery, Norfolk Beach, July 2020

Based on this information it is apparent that there has been recent unaddressed storm erosion on Norfolk Beach. However, photos taken by BMT in July 2020 (see Figure 4-1 and Appendix F) show active beach recovery and significant recovery of the beach is likely given sufficient time. As concerns have been raised by community members that if no action is taken erosion will be exacerbated by future storms, remedial action is recommended to accelerate recovery of Norfolk Beach and provide a greater buffer against future events. This is discussed further in section 6.3.5 and section 8.

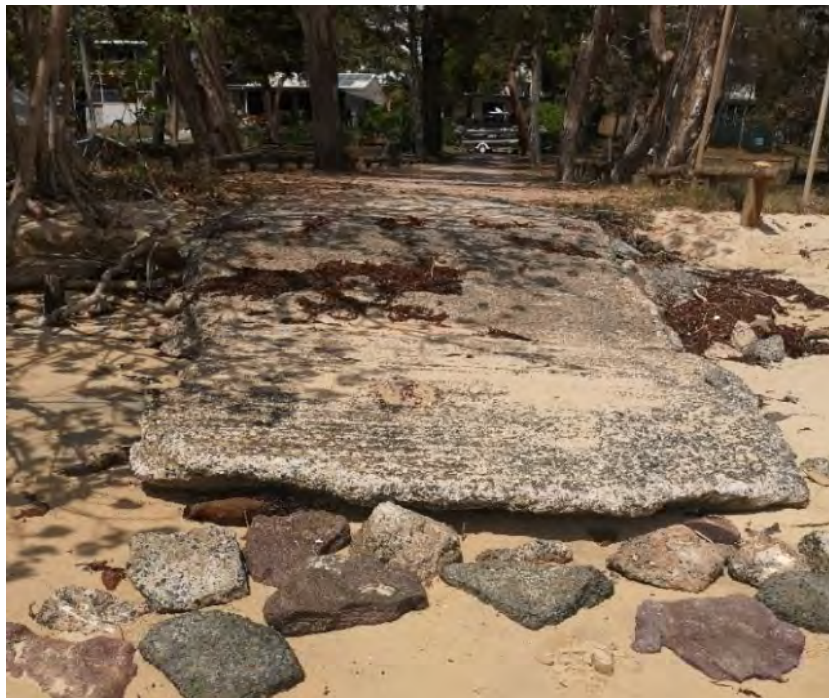
Figure 6-2 Morwong Beach Boat Ramp, March 2019

Council have requested that the SEMP consider options for the existing boat ramp on Morwong Beach. Based on the information provided we understand that this structure was constructed without approvals and is currently closed due to safety concerns. Due to the short nature of the boat ramp and its location at the top of the beach current interaction with coastal process is minimal and any impacts are localised to the immediate vicinity of the boat ramp.

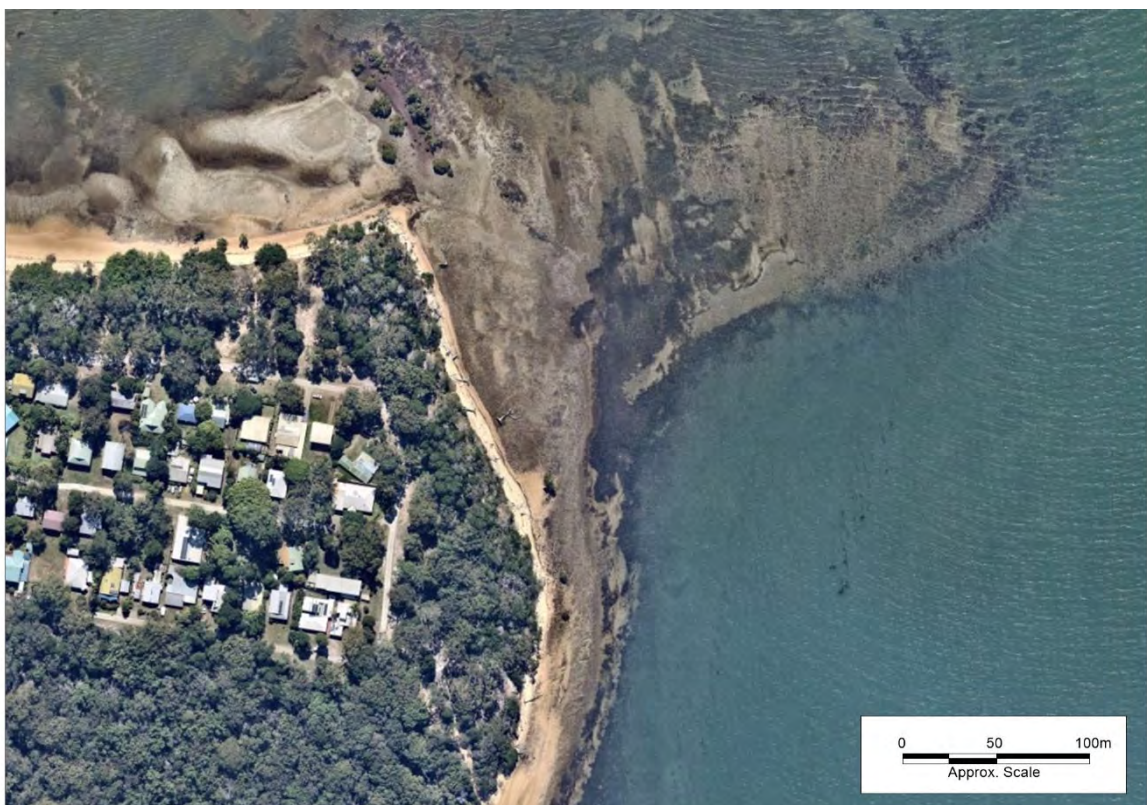
Figure 6-3 North-eastern Norfolk Beach (Nearmap 2020)

Aerial photographs from 1955 and 1997 show the rock outcrop connected to Morwong and Norfolk beaches by a sand spit forming a tombolo. Loss of vegetation on the rock outcrop and sand spit occurred between 1955 and 1997, with subsequent erosion of the connecting spit occurring between 1997 and 2013. Aerial photography indicates erosion of up to approximately 20 m since 1955. Minimal change in the vegetation line has occurred in the vicinity of Control Point 4 at the southern end of the beach segment.

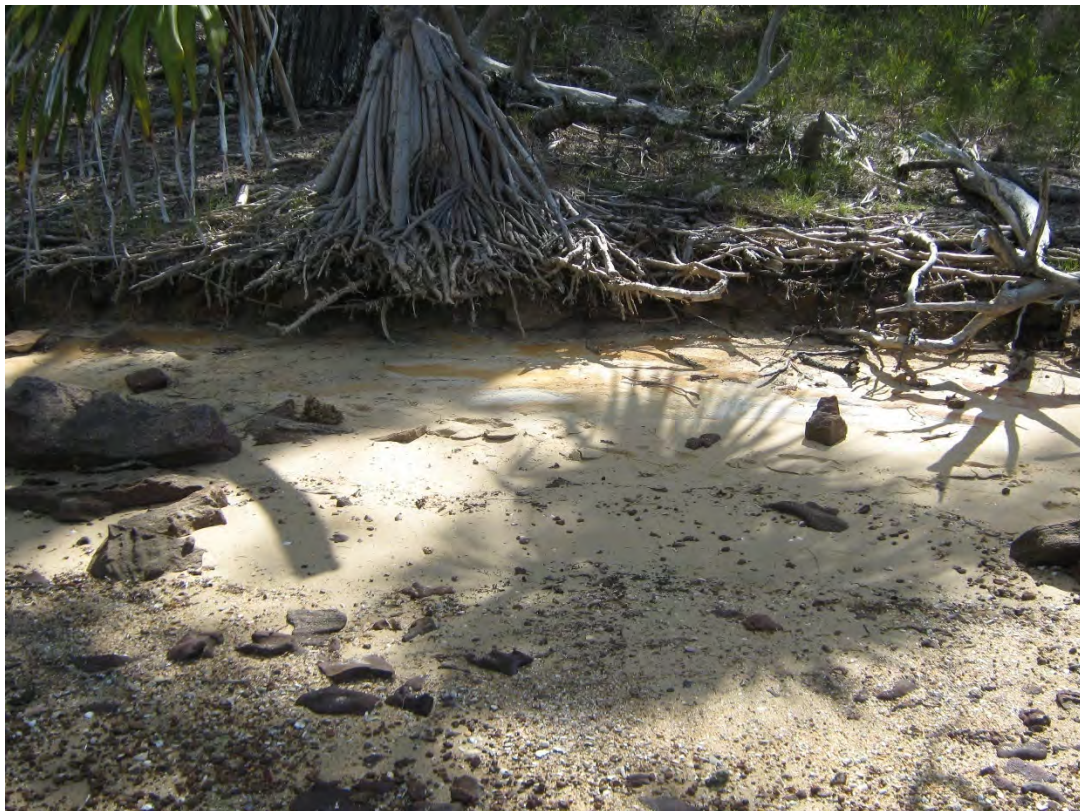
Figure 6-4 Exposed rock substrate North-eastern Norfolk beach (October 2018)

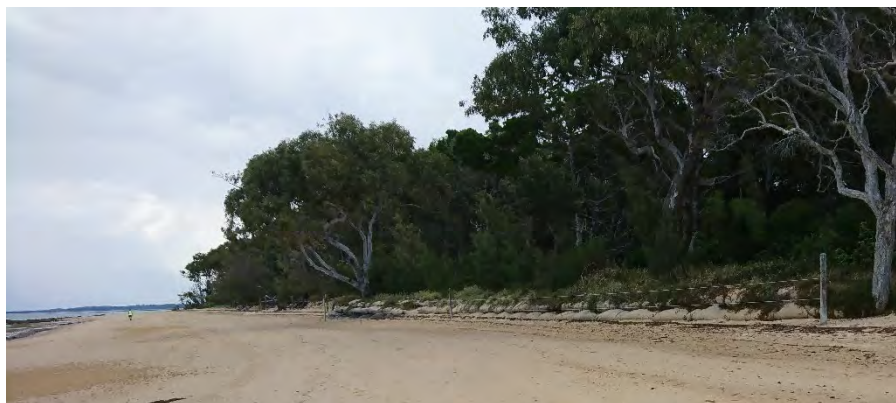
Figure 6-8 Northern geotextile container seawall - October 2018

While there is a cost associated with removal it should be noted that the design life expectancy of a geotextile structure is in the order of 15-20 years and the structure will require removal or replacement at some time in the future.

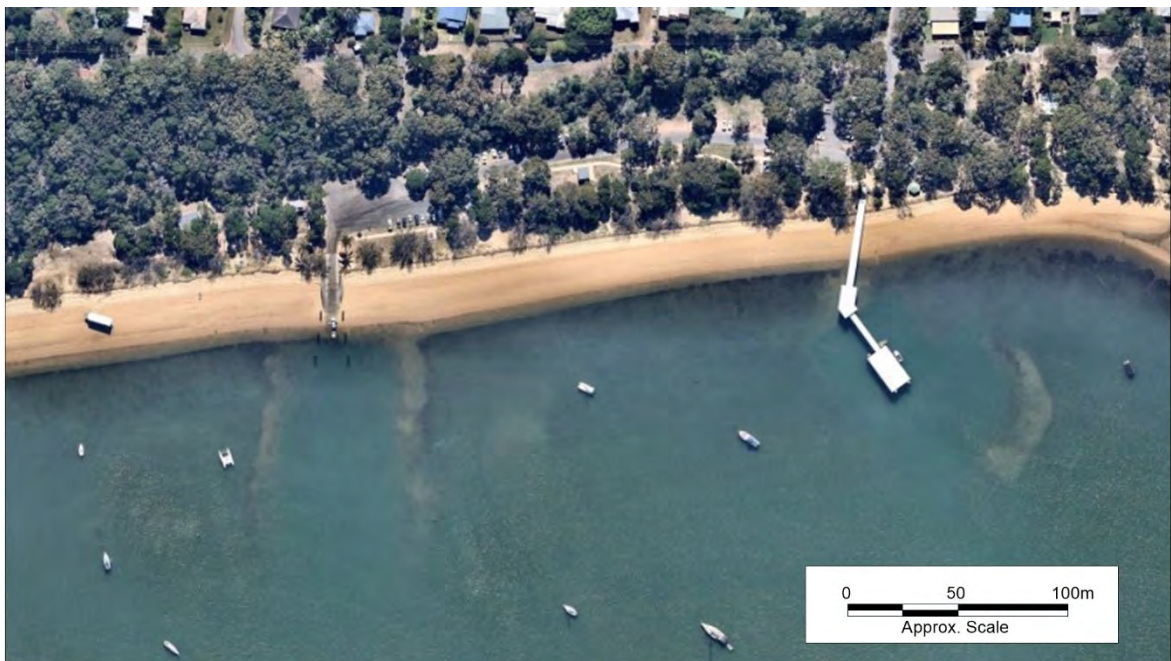
Figure 6-13 Main Beach between Ferry Terminal and Barge Ramp (Nearmap 2020)

Aerial photography indicates an accretion of up to 12 m from 1997 to 2018. The barge ramp upgraded in 2018 and has had accumulations of sand on its eastern edge since completion.

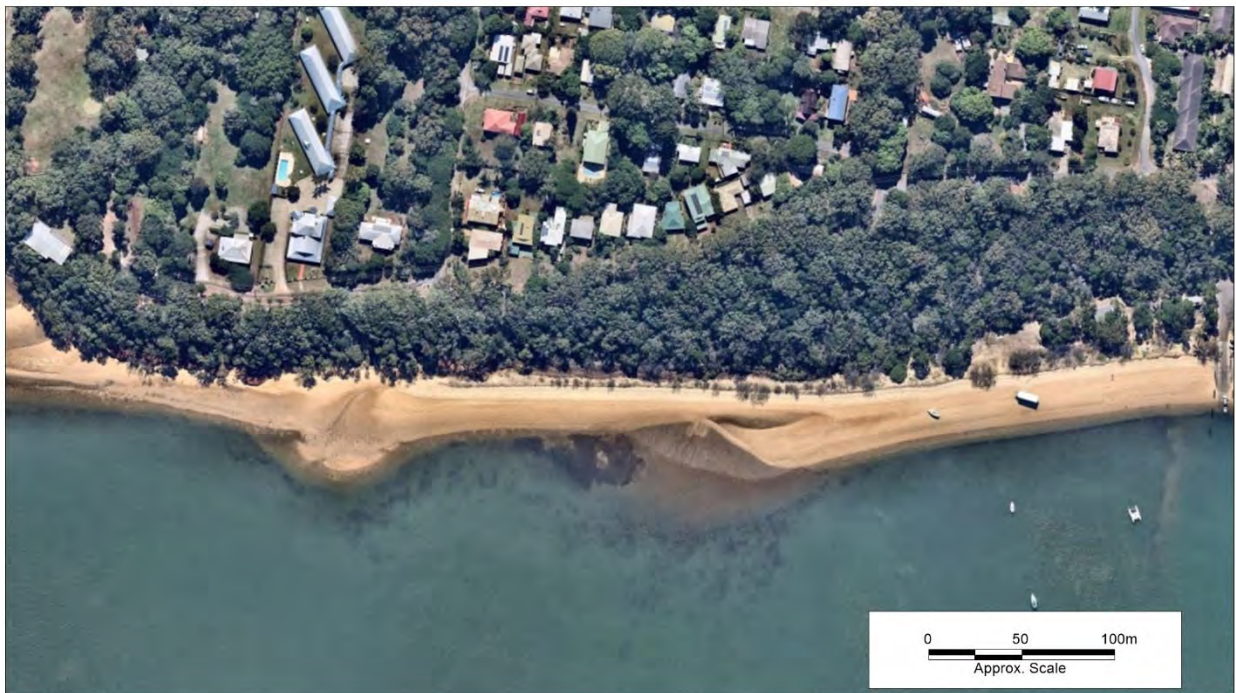
Figure 6-14 Main Beach between Barge Ramp and Red Cliffs (Nearmap 2019)

The Curlew Creek outlet runs behind this section of beach and the alluvial fan at its entrance is clearly seen in the aerial photographs. This creek outlet will naturally move in response to longshore sand transport, storm erosion and rainfall events so the beach may appear to accrete or erode in different locations in response to flows in the creek. Vegetation immediately adjacent to the beach (between the creek and the beach) is mostly ground cover/grasses as opposed to large trees. Comparison of the seaward edge of vegetation (BMT, 2020) shows minimal change between 1955 and 1997 (with subsequent increase in vegetation from 1997 to 2013). Unless safety concerns or immediate threats to infrastructure emerge in the future these natural processes should be allowed to continue.

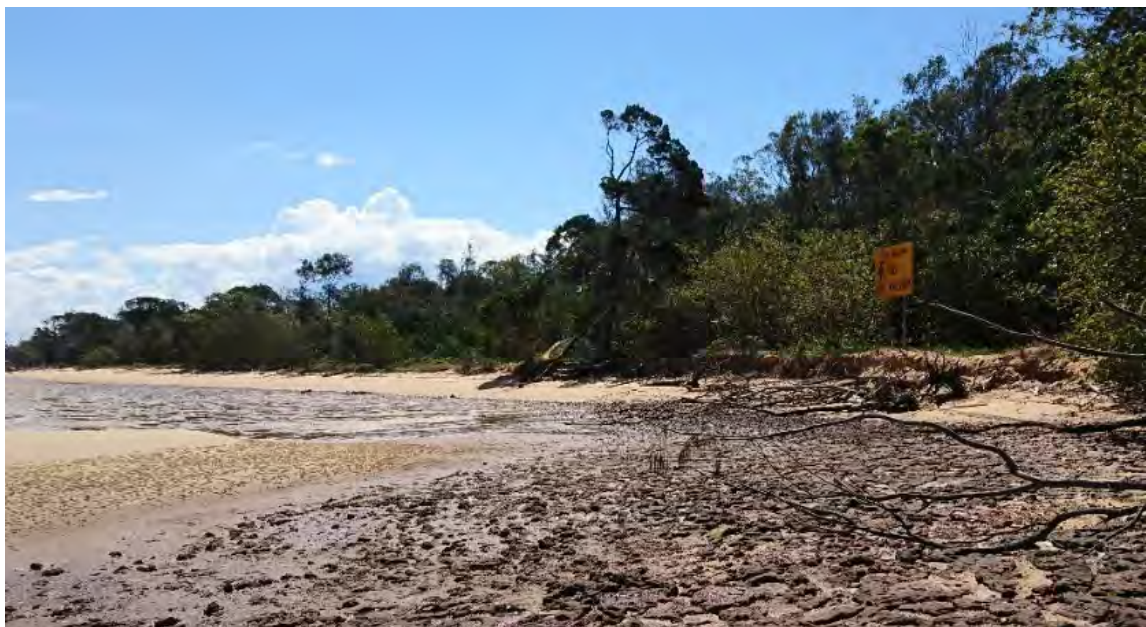
Figure 6-16 Main Beach fronting the Golf Course - fallen warning sign in the centre of the photo (October 2018)

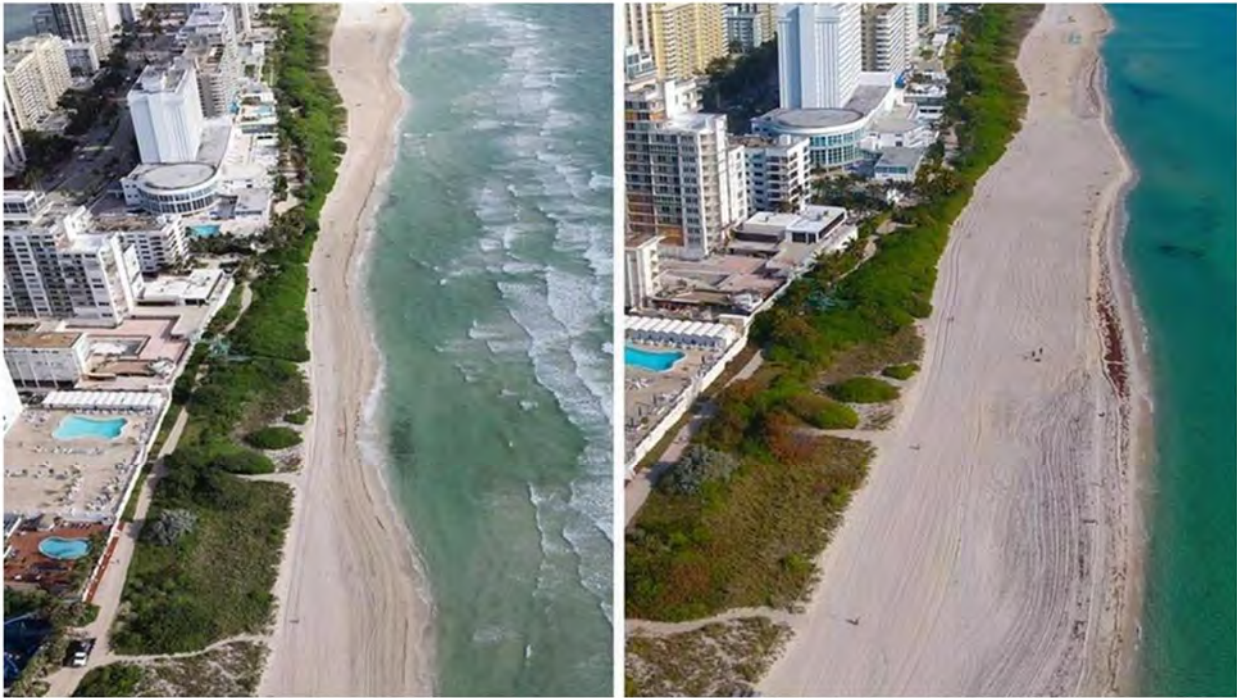
Figure C-2 Beach nourishment before (left) and after (right)

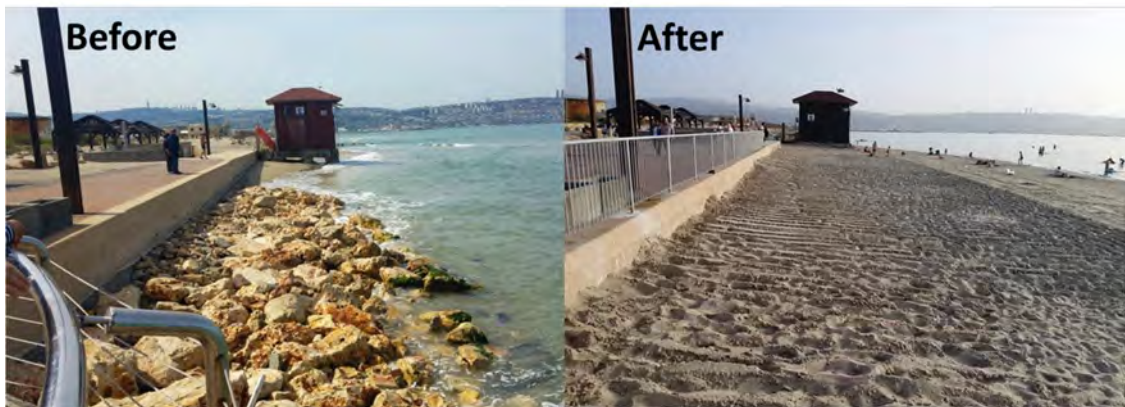
Figure C-3 Beach nourishment before (left) and after (right)

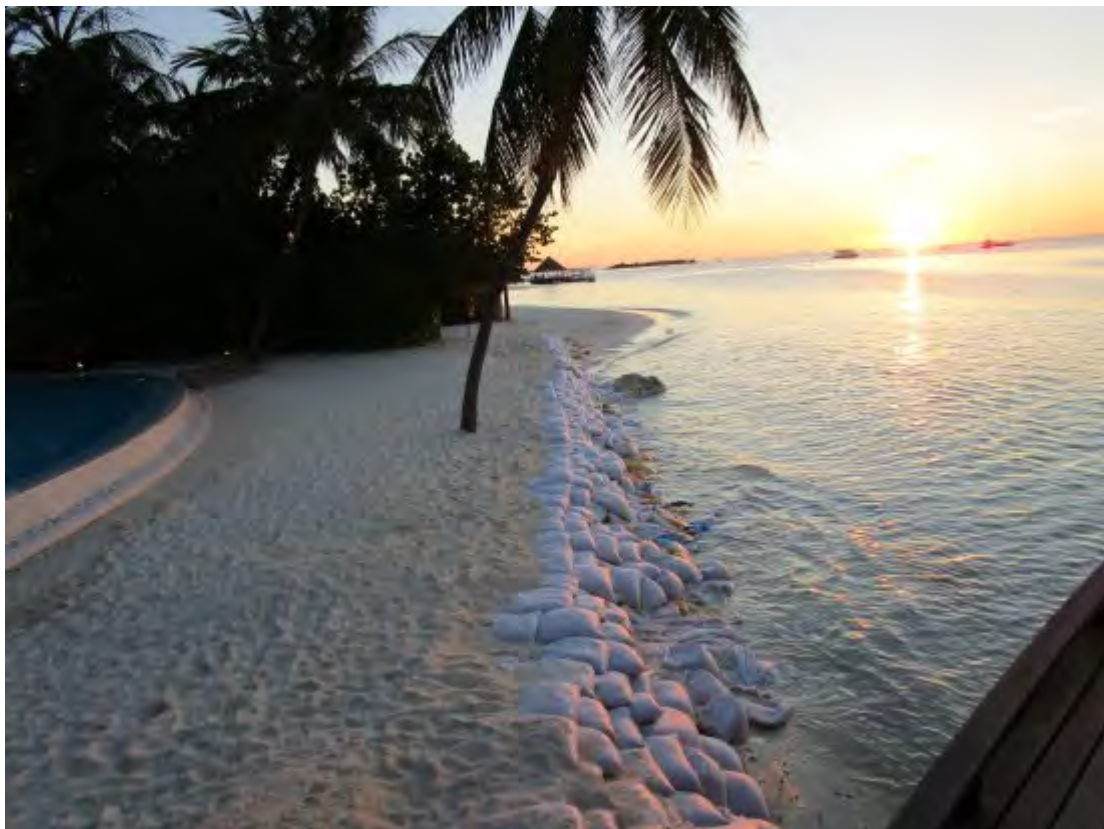
Figure C-6 Eroded beach in front of a geotextile container seawall

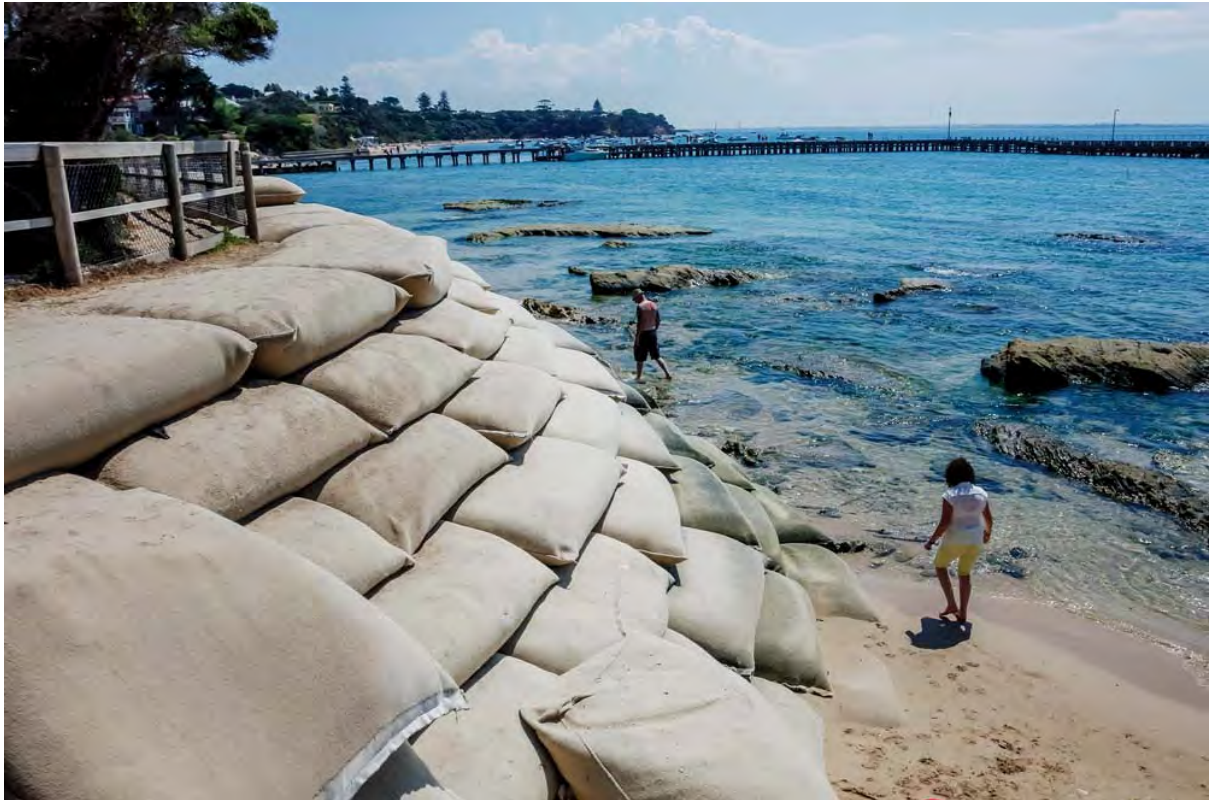
Figure C-7 Eroded beach in front of a geotextile container seawall

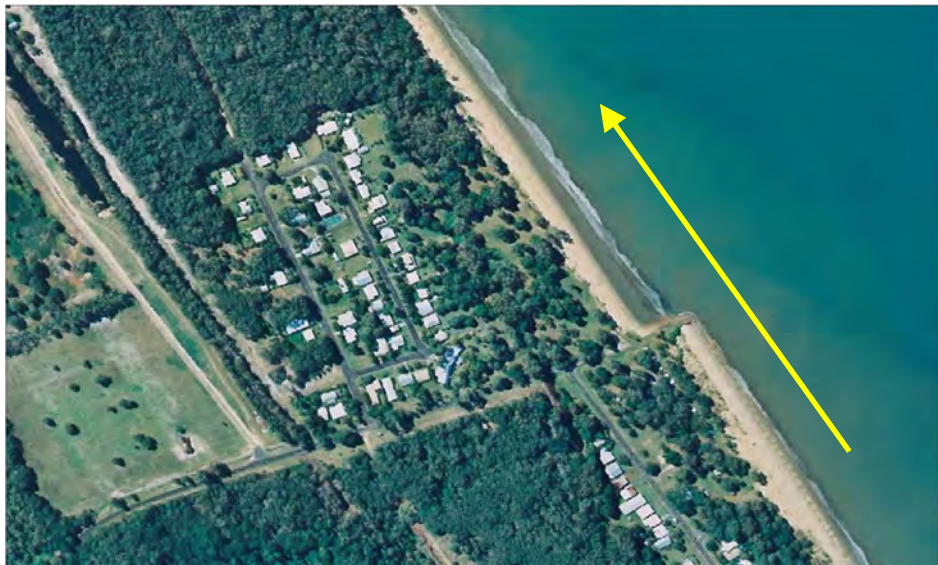
Figure C-8 Typical groyne result with longshore transport. Arrow indicates direction of sand transport

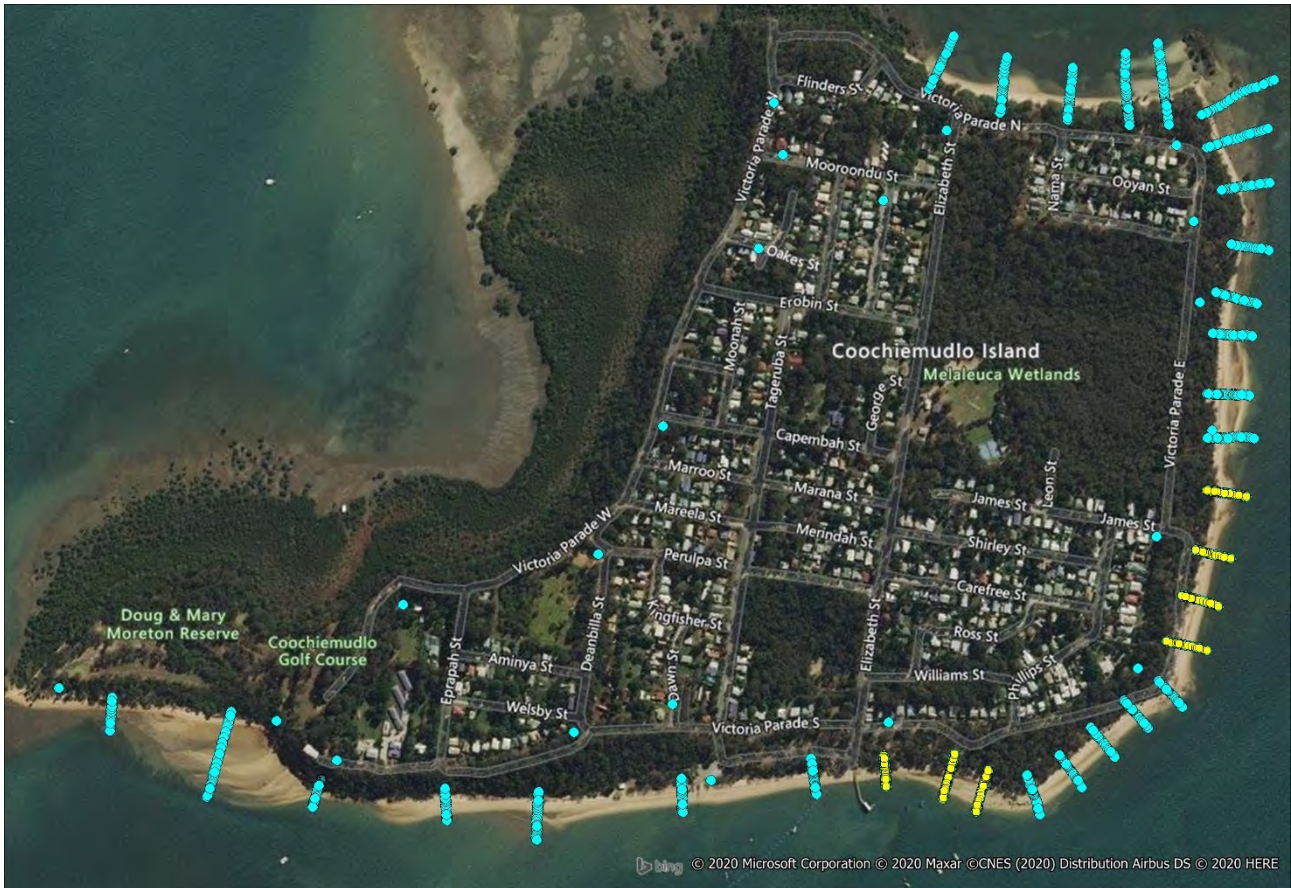
Figure D-1 2020 Survey, all points. Yellow indicates profiles that have been surveyed previously.
