Coochiemudlo Island Shoreline Erosion Management Plan and Operational Plan

Reference: R.B23255.002.04.CMI_SEMP.docx
Date: November 2020
Confidential

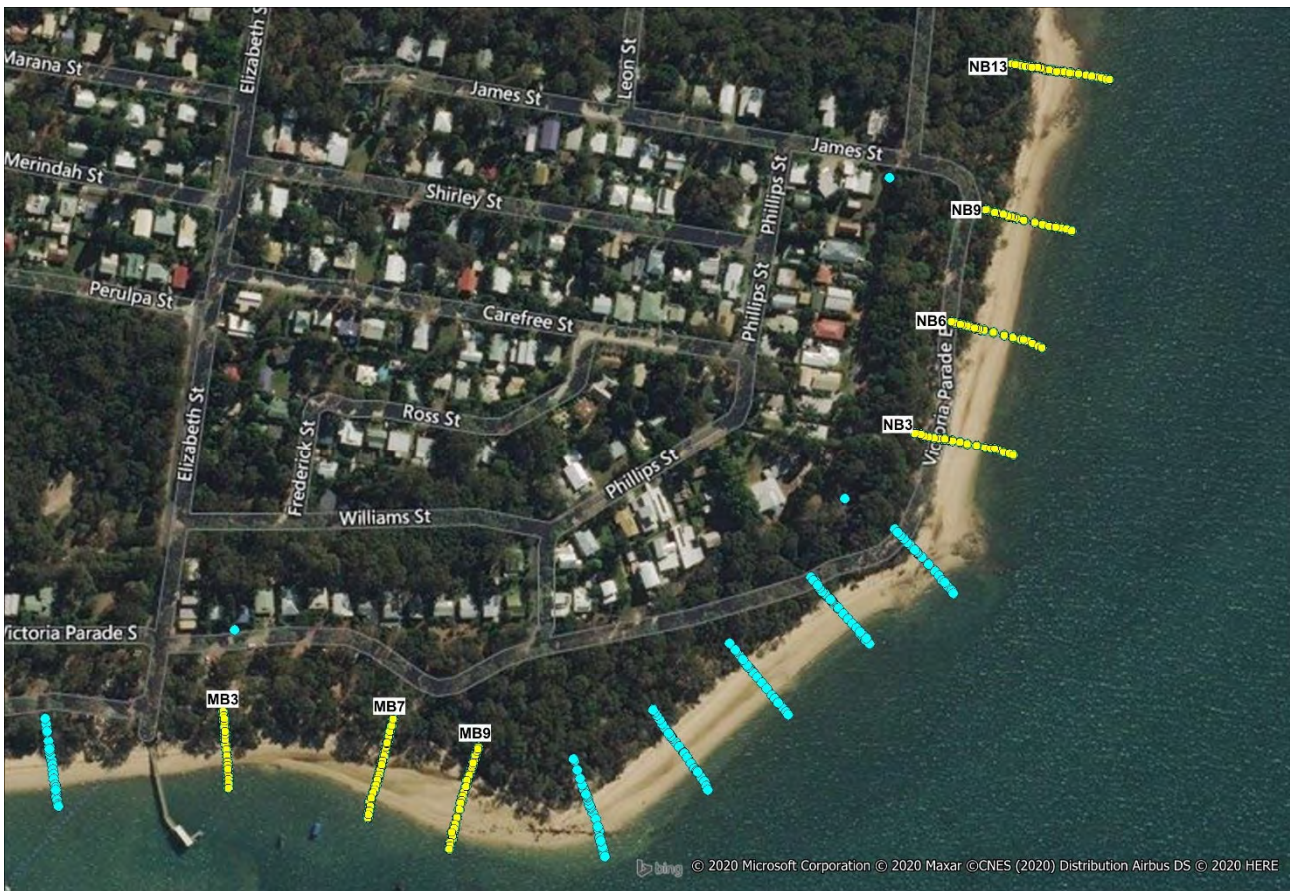
Figure D-2 2020 Survey, Main beach east of the Ferry Terminal, South-east Norfolk Beach and Norfolk Beach fronting Victoria Parade. Yellow indicates profiles that have been surveyed previously

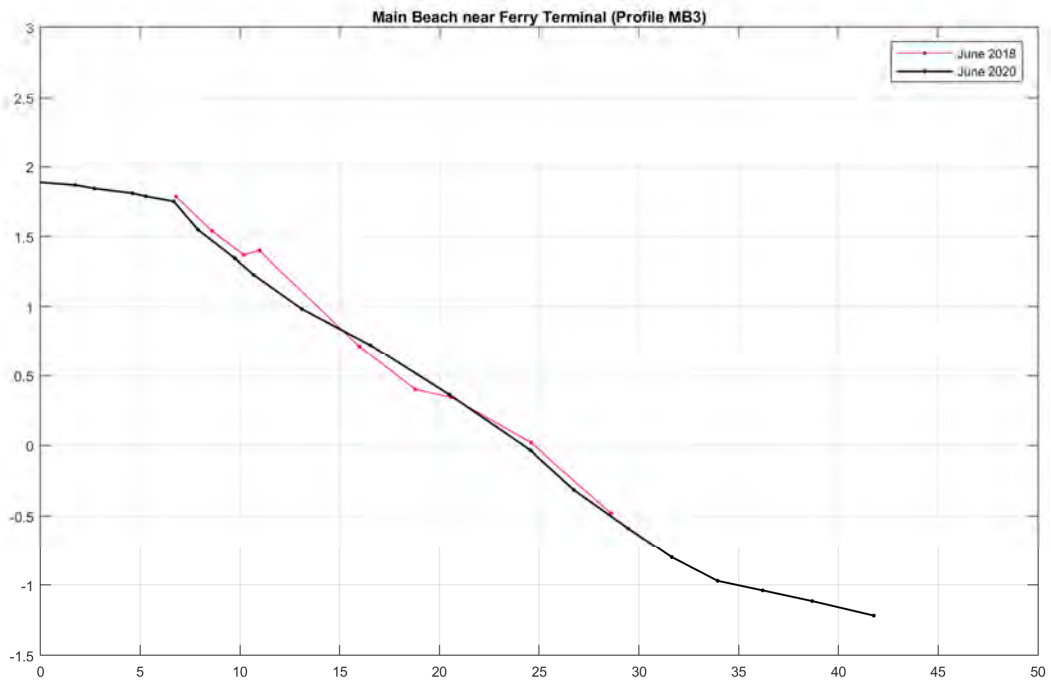
Figure D-3 June 2018 and June 2020 surveys, Profile MB3, Main Beach

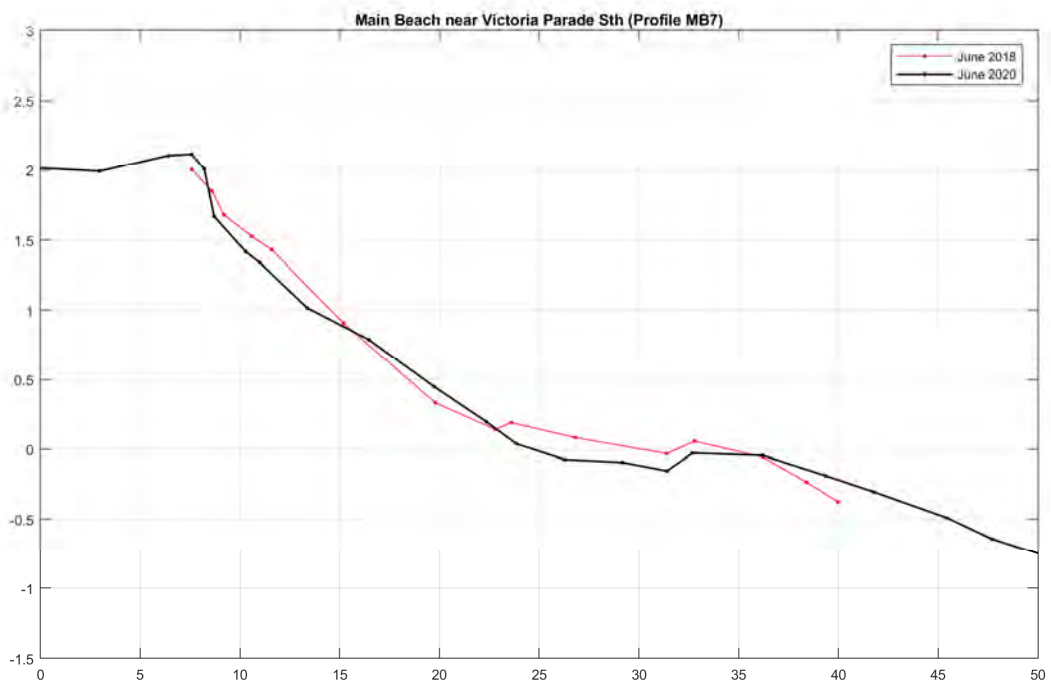
Figure D-4 June 2018 and June 2020 surveys, Profile MB7, Main Beach

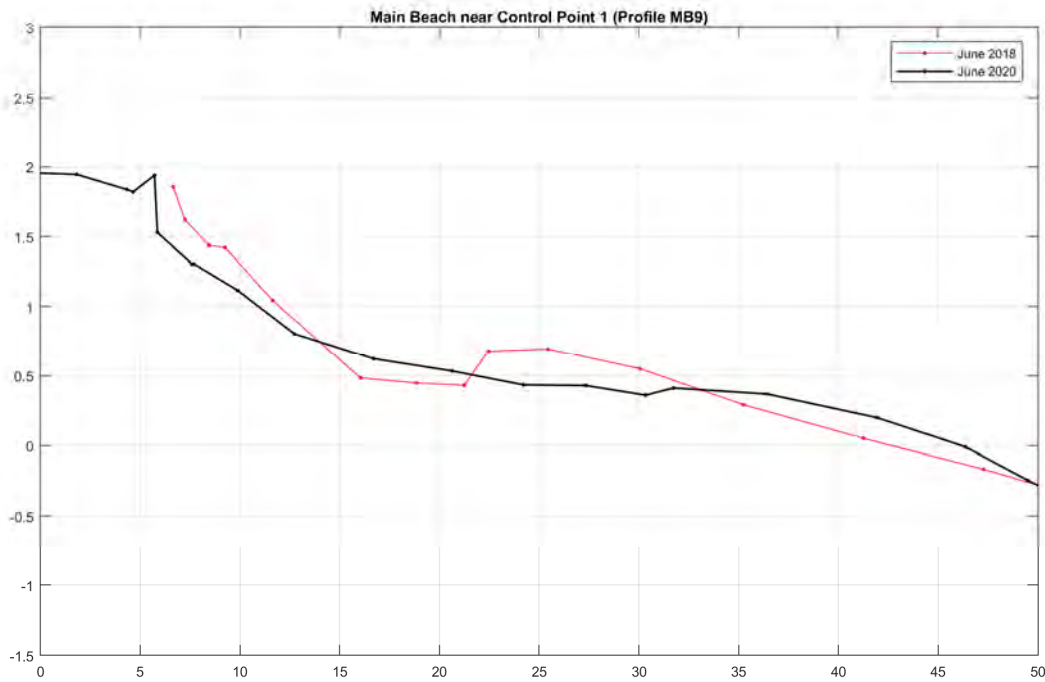
Figure D-5 June 2018 and June 2020 surveys, Profile MB9, Main Beach

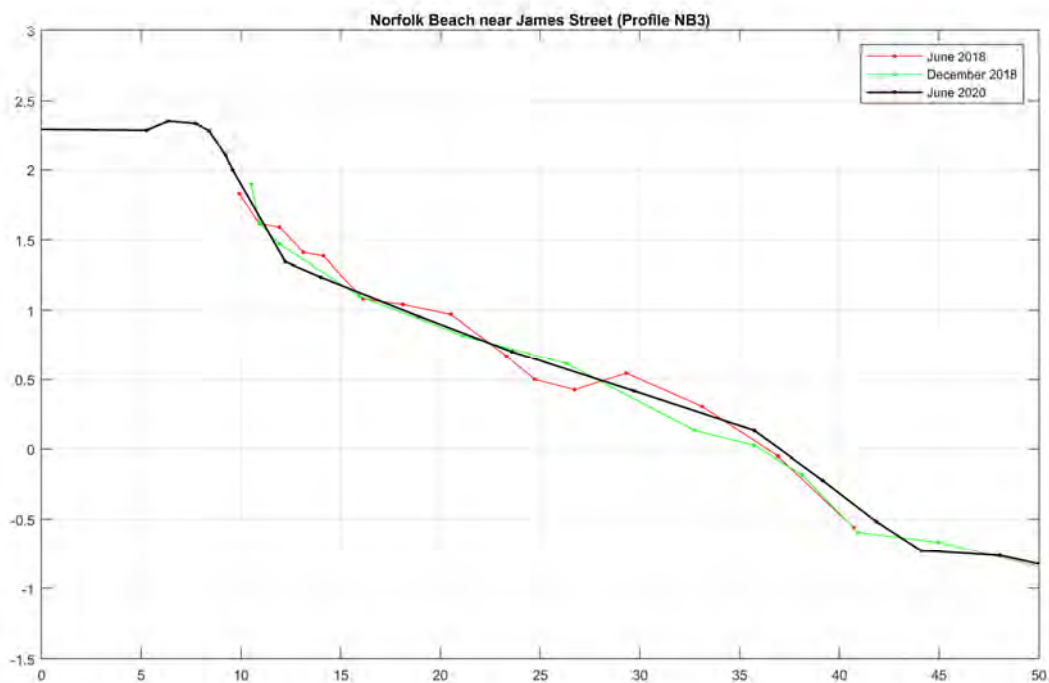
Figure D-6 June 2018, December 2018 and June 2020 surveys, Profile NB3, Norfolk Beach

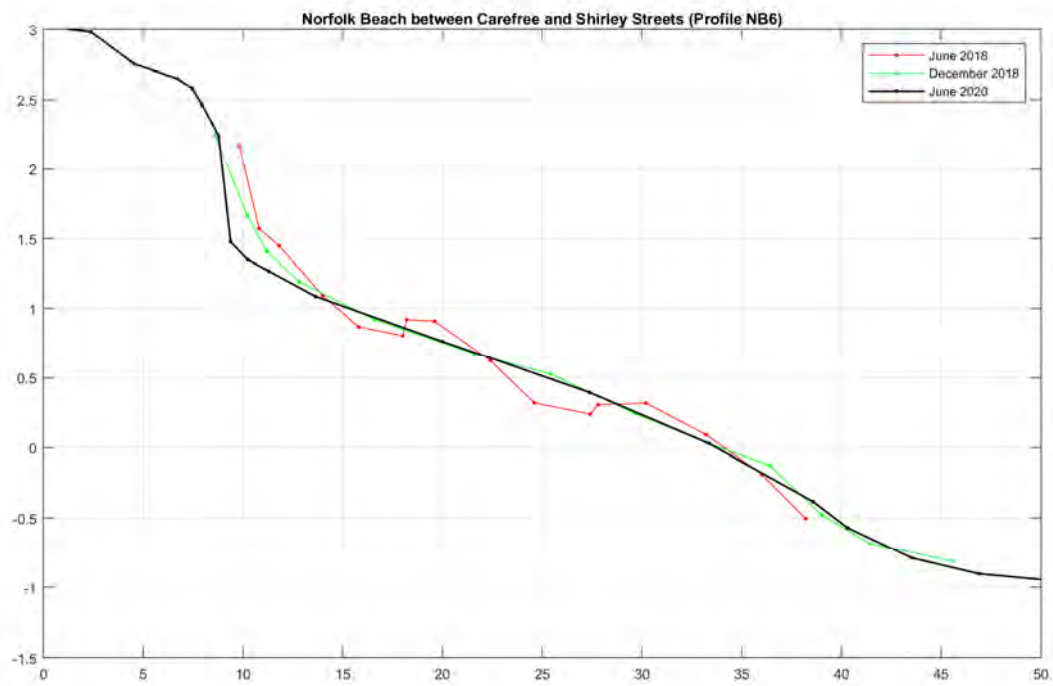
Figure D-7 June 2018, December 2018 and June 2020 surveys, Profile NB6, Norfolk Beach

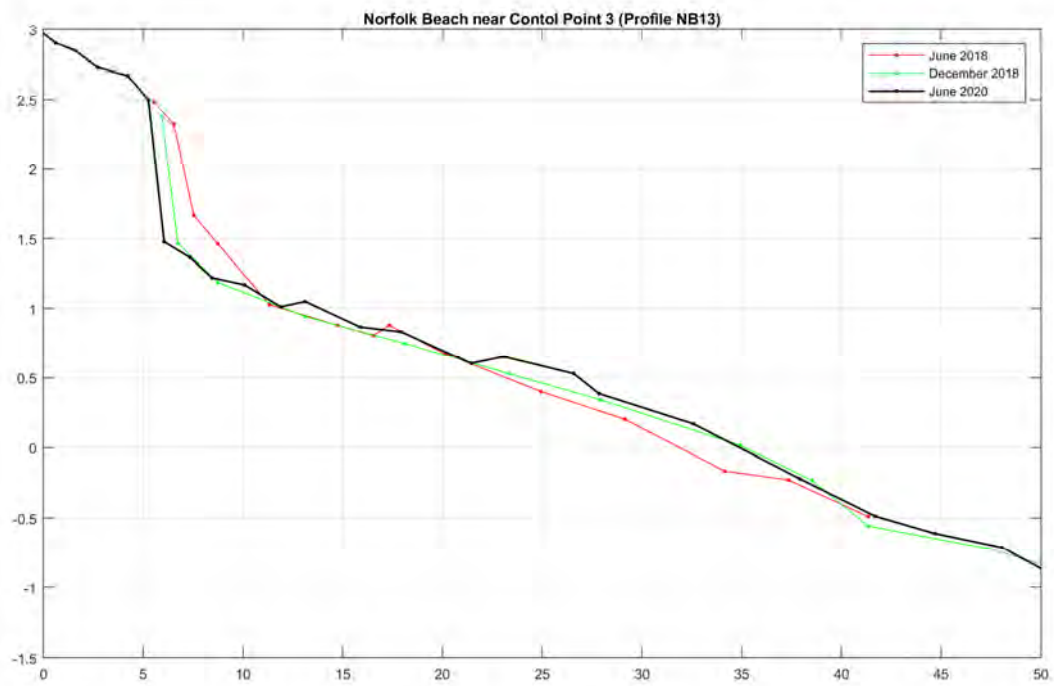
Figure D-9 June 2018, December 2018 and June 2020 surveys, Profile NB13, Norfolk Beach

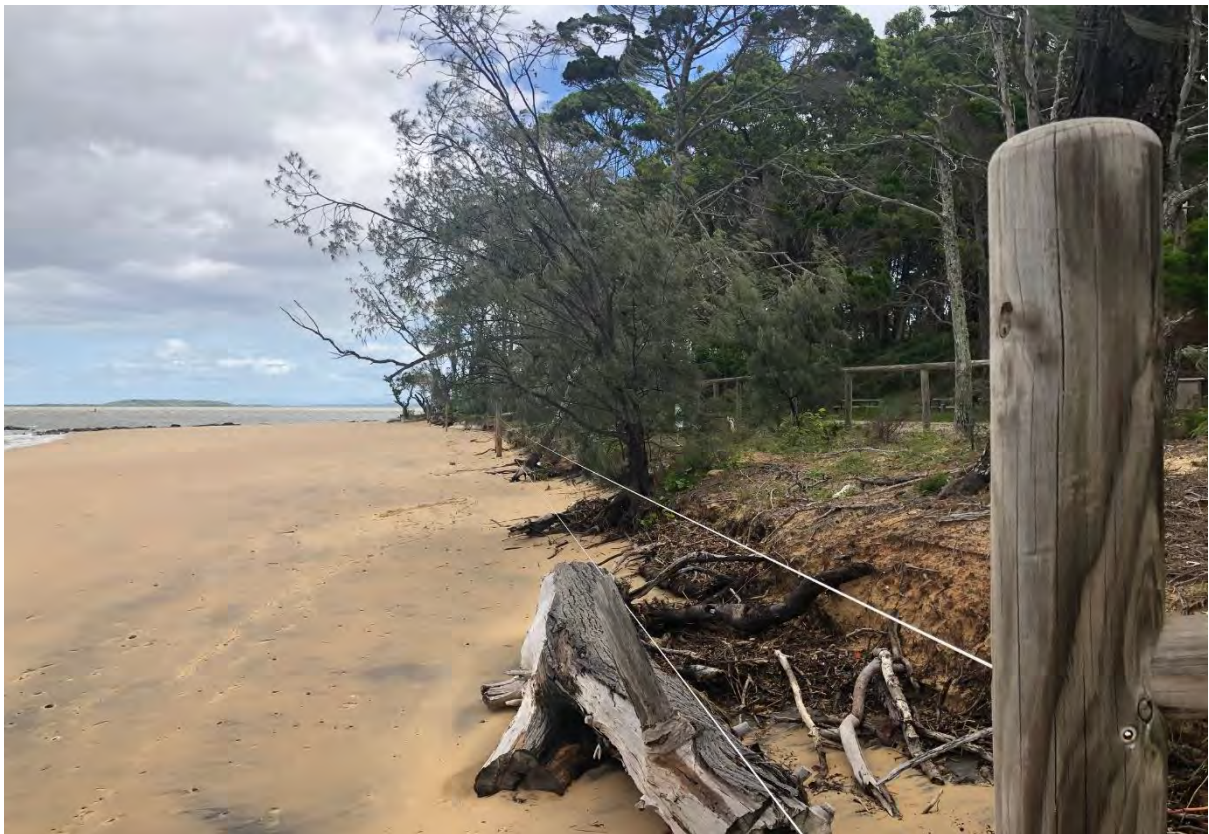
Same spot 11 March 2020 – Note erosion & this is the least eroded section on Norfolk Beach today

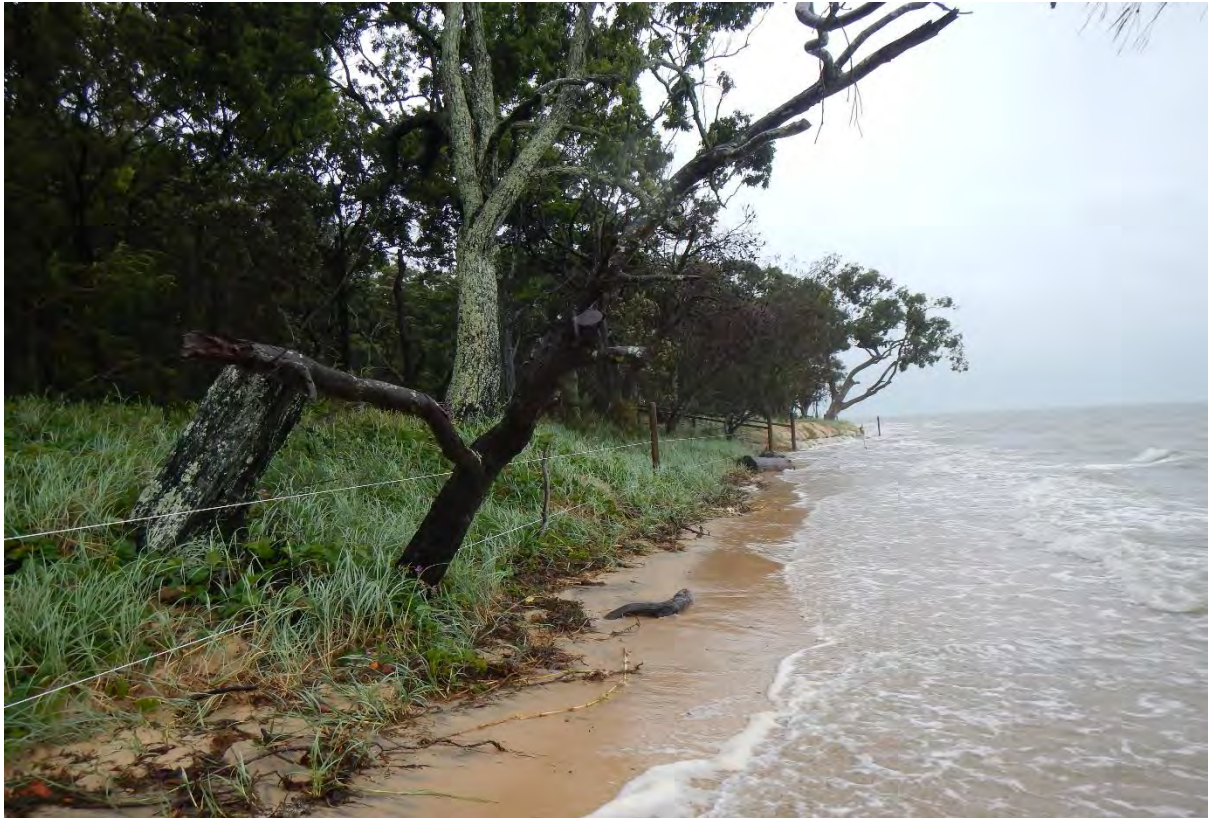
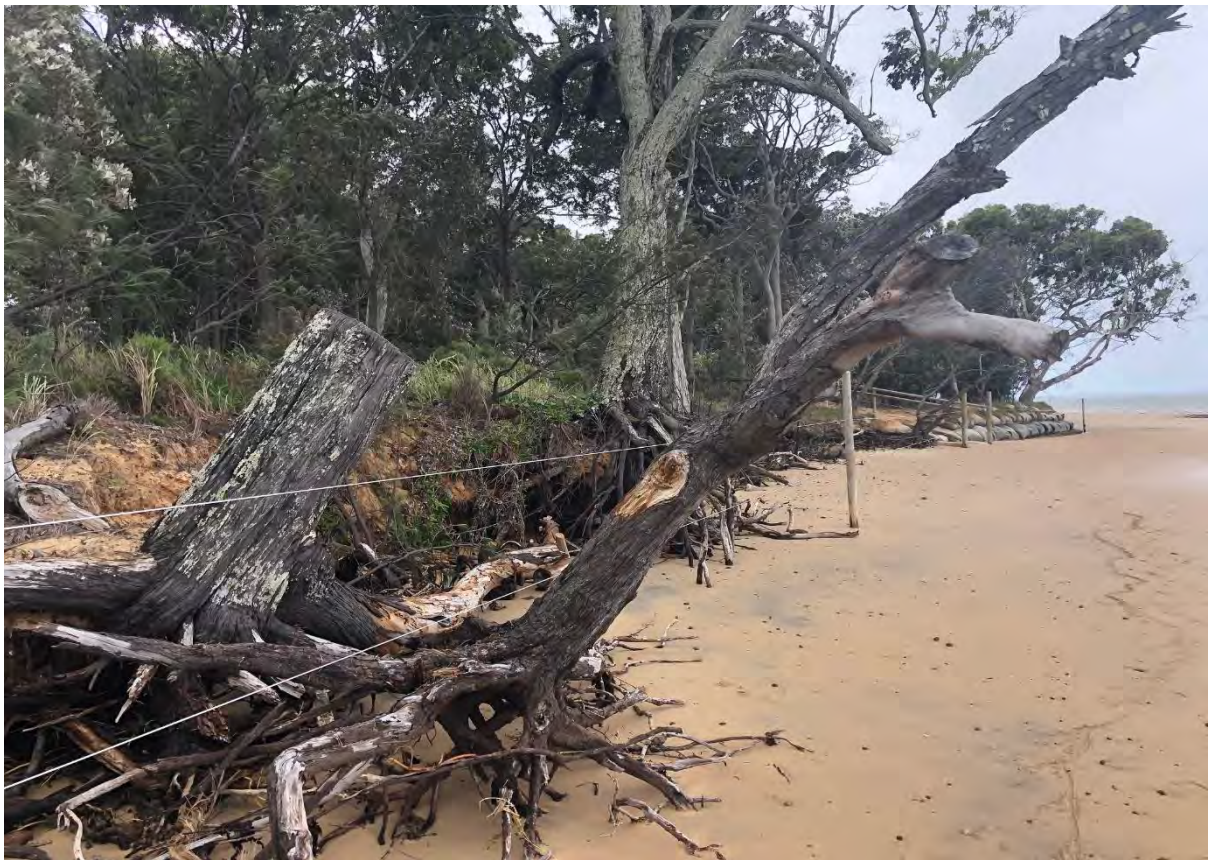
Looking north to CP3. Compare the top photo from May 2015 to the bottom, 11 March.2020 - Note the loss of vegetated dune , particularly in front of the fence line

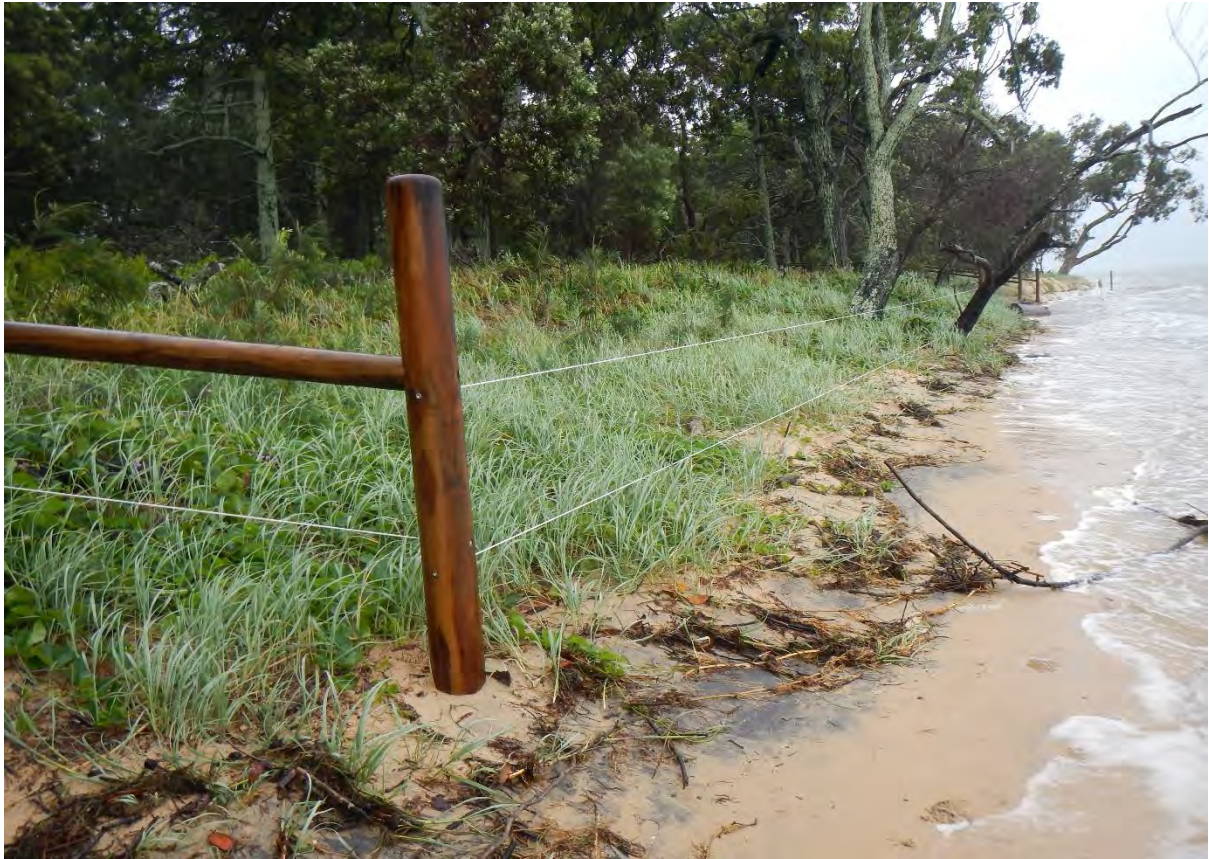
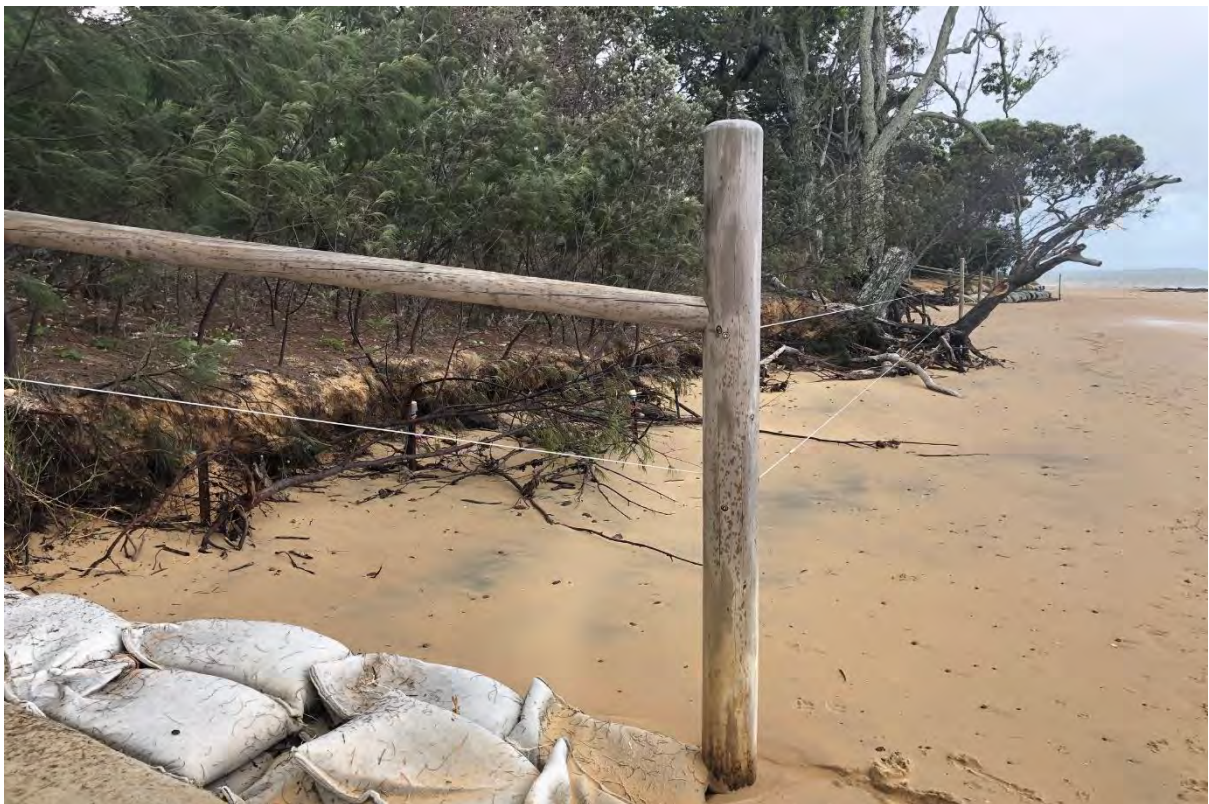
Northern access to Heritage precinct looking north – note top photo from 3 May 2015 lush vegetated dune compared to the eroded scarp 3 metres from the fence-line yesterday - 11 March 2020

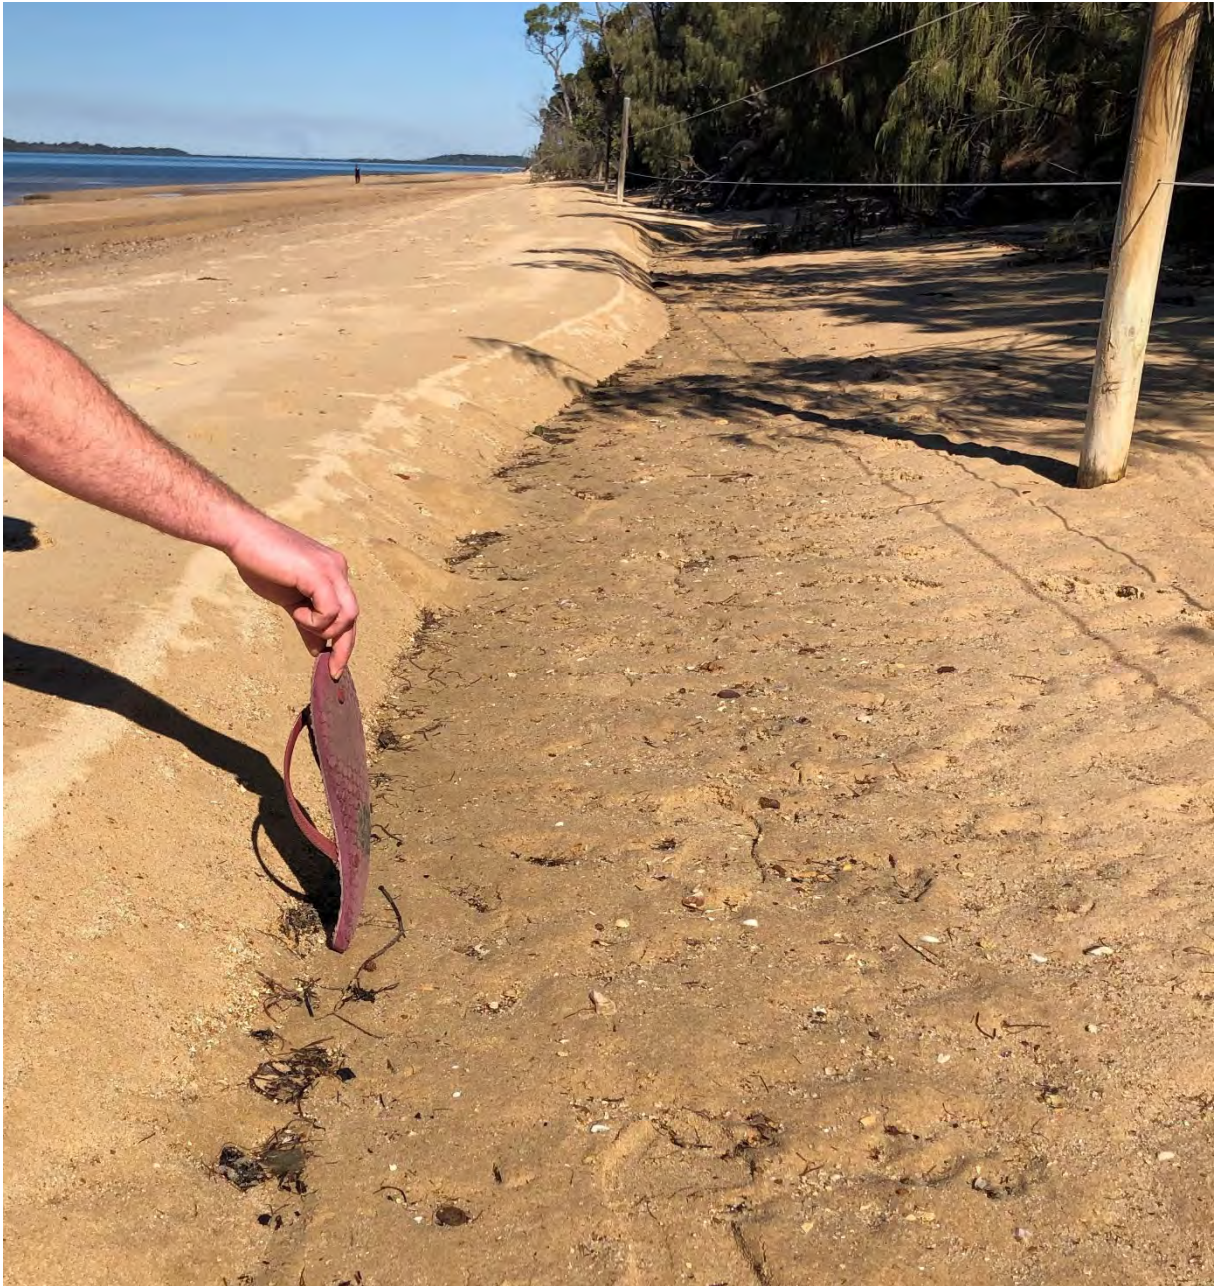
Figure F-5 Active beach recovery – Norfolk Beach (shoe to indicate scale)

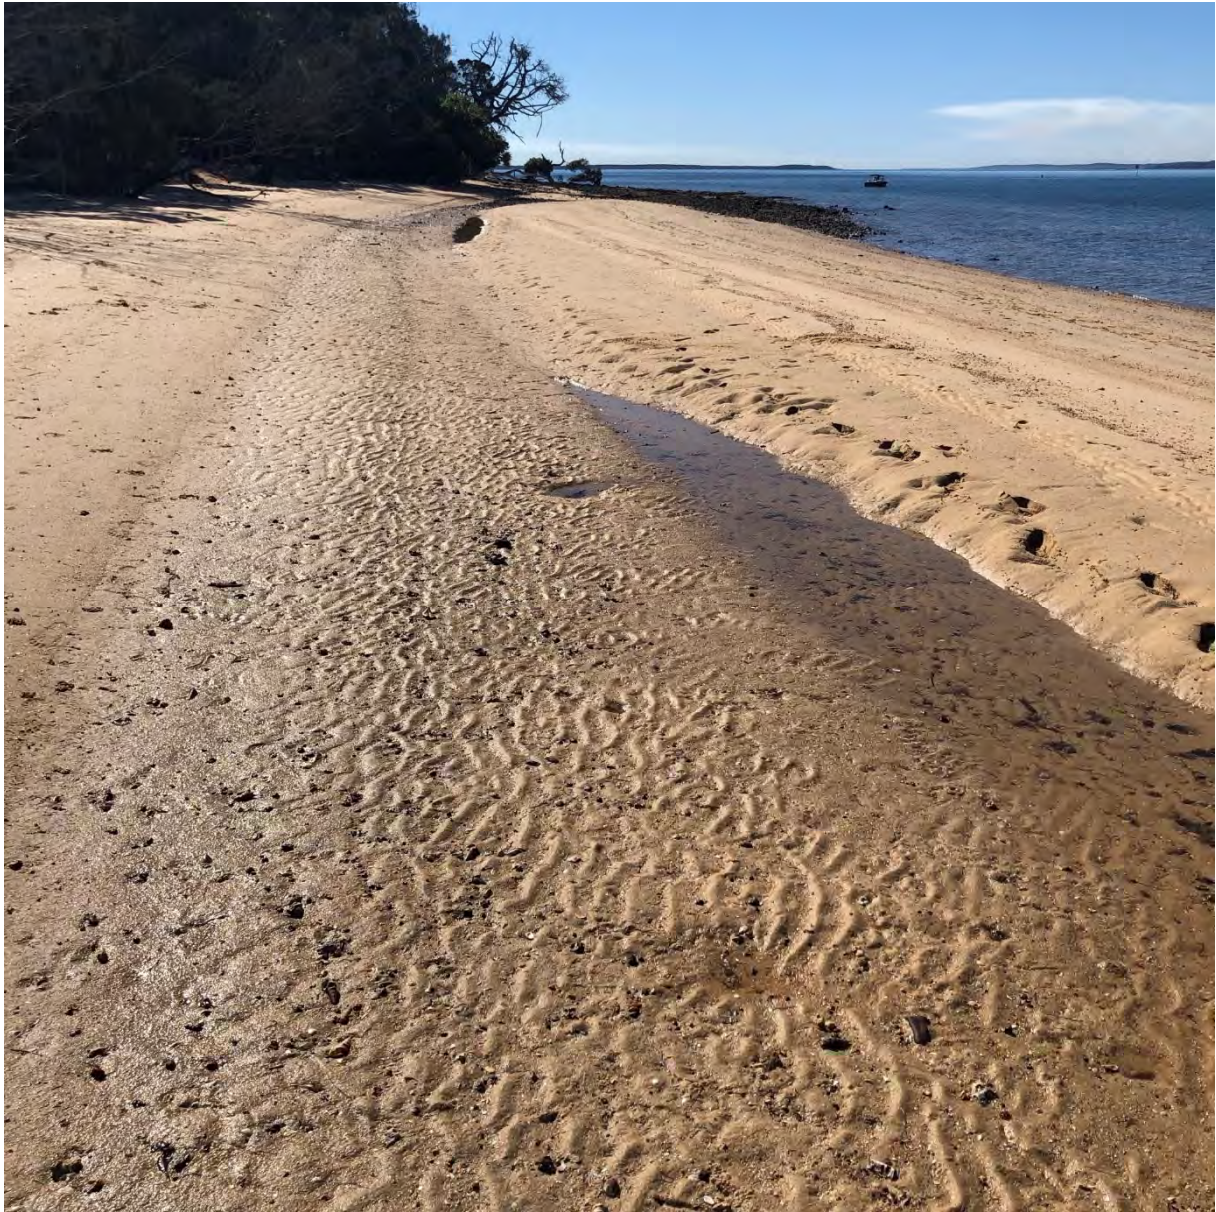
Figure F-7 Beach recovery (Melaleuca Wetlands looking north to Control Point 4)
